**CITY OF BOULDER FUNDED RESEARCH PROGRAM**

**Final Report:**

**Restoring for resilience: Assessing the restoration success of flood recovery projects on Left Hand Creek, Boulder County, Colorado**

**LEFT HAND WATERSHED CENTER**  
6800 Nimbus Road, Longmont CO 80503 (office)  
P.O. Box 1074, Niwot, CO 80544-0210 (mailing)  
303.530.4200 | [www.watershed.center](http://www.watershed.center)

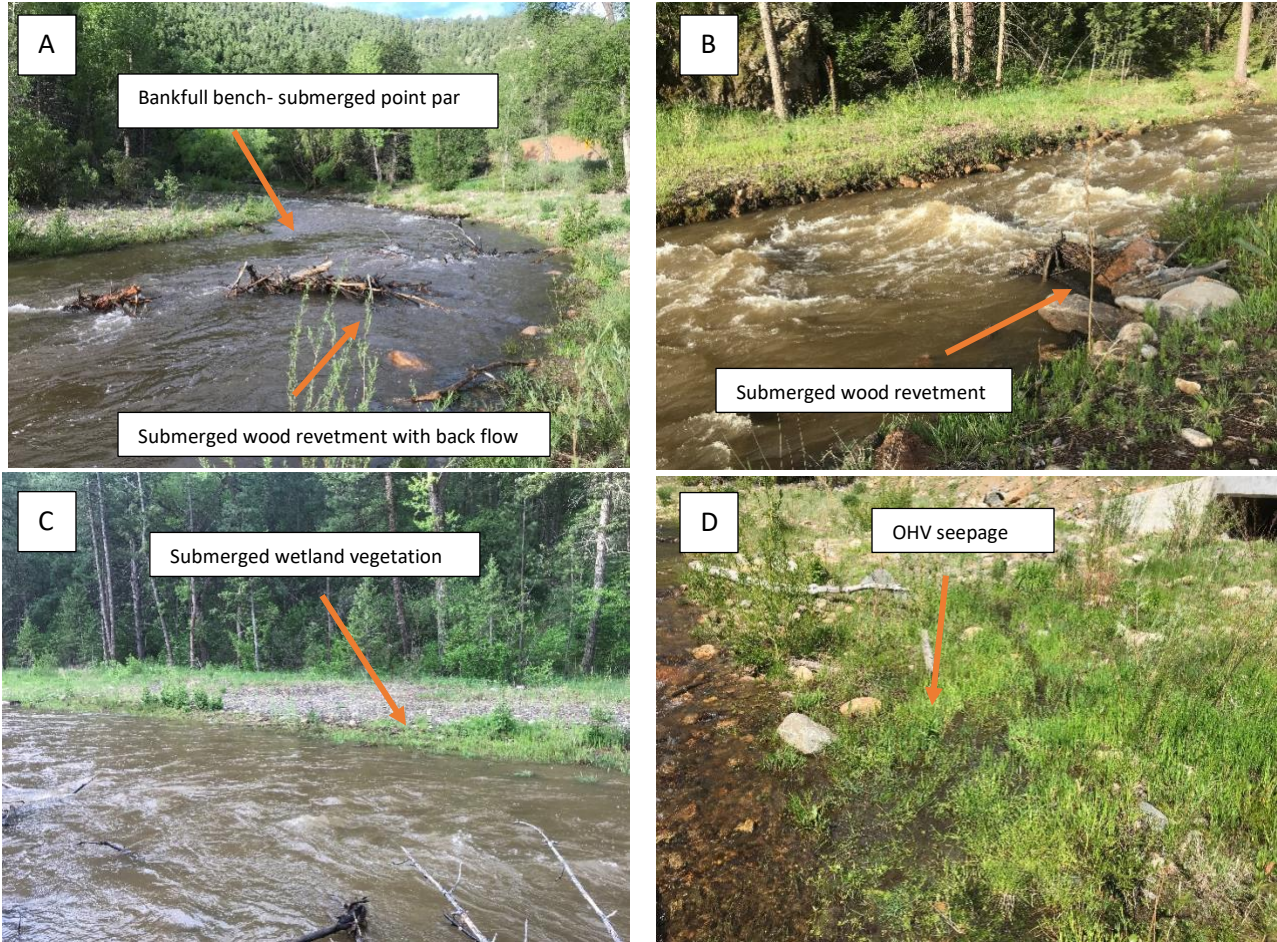
In 2020, peak flow measured 212 cfs on Left Hand Creek occurred from May 31 through June 1, 2020 (Figure 3). Both Upstream Buckingham and Buckingham were monitored on June 2, 2020. While bankfull benches were activated at the floodplain pocket and confined sections of each site, we found that features within the bankfull bench (e.g. wetland vegetation, point bars) were activated differently depending on site. Floodplain pockets are sections of creek with broader access to the floodplain, while confined areas have limited floodplains due to canyon walls, roads, or other development. At Upstream Buckingham, we found that 2020 peak flow activated bankfull bench (see Figure 2 for reference) throughout the project area (both the upstream floodplain pocket and downstream confined area). More specifically, peak flows activated the upstream point bar (Figure 6, Photo A), submerged and flowed behind large wood structures (Photo A and B), submerged wetland vegetation (Photo C), and promoted seepage at the upstream OHV area drainage (Photo D). At Buckingham, we found that 2020 peak flows also activated the bankfull bench, but activated different features depending on location within the site area. In the upstream floodplain pocket, peak flows activated wetland vegetation, including the lower floodplain, and activated the side channel (Figure 7, Photo A). In the downstream confined area, peak flows did not activate wetland vegetation (Photo B). This is likely due to channel incision and less connectivity between the stream and floodplain at Buckingham compared to Upstream Buckingham.

Figure 5. Peak seasonal flow observations from 6/2/2020 at restored Upstream Buckingham on Left Hand Creek. Photo description match letter and arrow: A. activated upstream bankfull bench, submerged point bar, and submerged wood revetment in upstream floodplain pocket; B. submerged wood revetment in downstream riffle in confined area; C. submerged wetland vegetation at downstream pool; D. seepage from upstream OHV drainage.

- Addressing our hypothesis: yes, 2020 peak flow inundated the appropriate restored bankfull benches at Upstream Buckingham.
- Floodplain connectivity in floodplain pocket areas were similar at both sites. Peak flows activated bankfull benches, including wetland vegetation and point bar features, at both sites and activated the side channel at Buckingham.
- Floodplain connectivity in confined areas differs between sites due to channel incision at Buckingham. Peak flows at Upstream Buckingham activated bankfull benches and submerged riparian vegetation, while peak flows at Buckingham activated bankfull benches without submerging wetland vegetation.
- Peak flows submerged and flowed behind wood revetments at Upstream Buckingham. There were no signs of scour behind the revetments during subsequent low flow monitoring.

- Continue monitoring wood revetments during peak flows for back flow and signs of scour that could erode the floodplain towards the road.

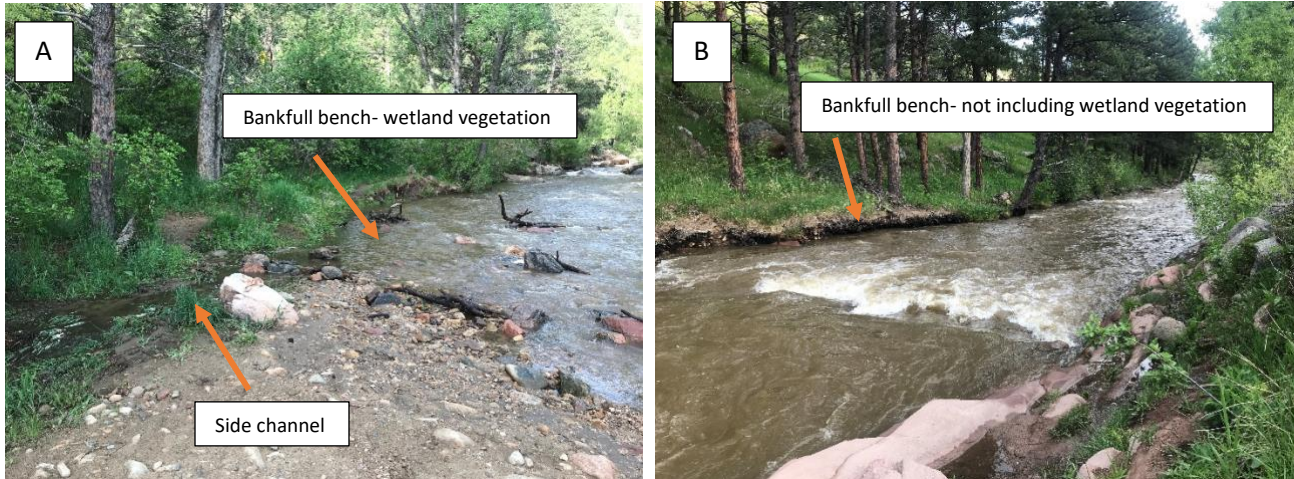
Figure 6. Peak seasonal flow observations from 6/2/2020 at unrestored Buckingham on Left Hand Creek. Photo description match letter and arrow: A. activated bankfull bench, including wetland vegetation, and side channel in floodplain pocket; B. activated downstream bankfull bench, not including wetland vegetation, in confined area downstream.

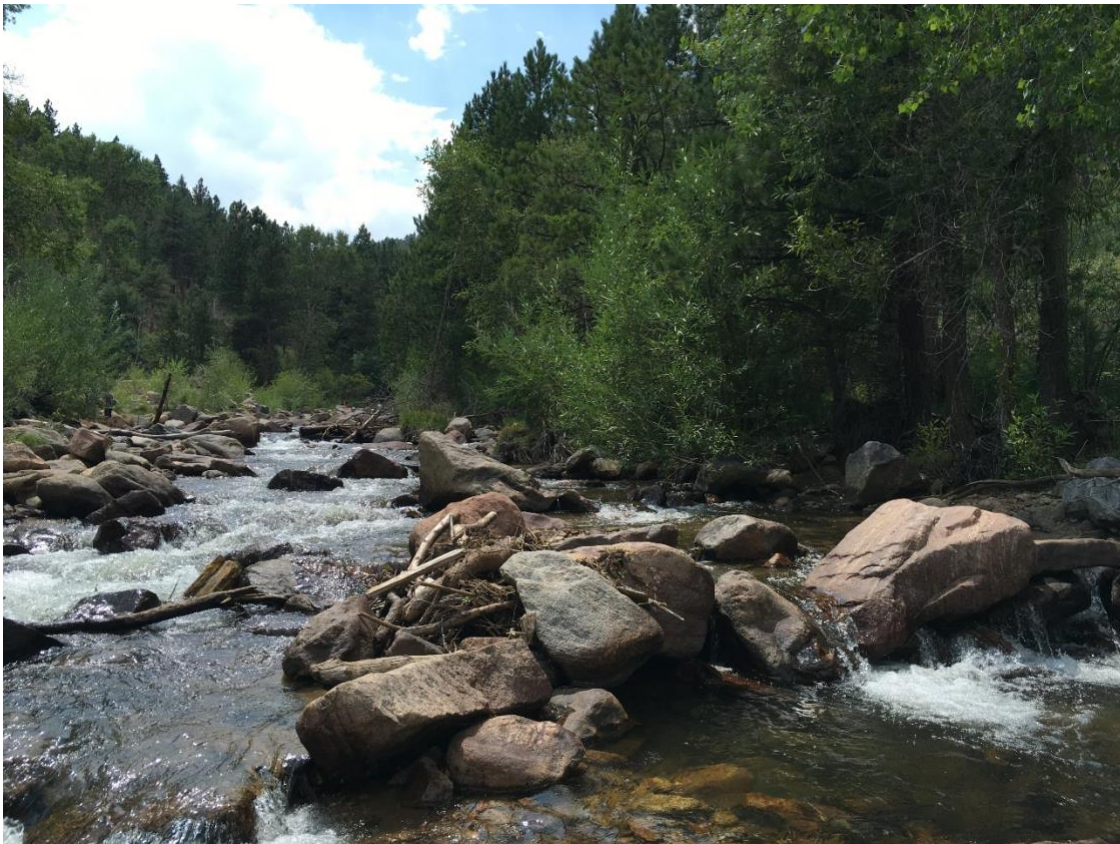
Figure 7. Photo of habitat complexity at the Buckingham site on Left Hand Creek. August, 2020.

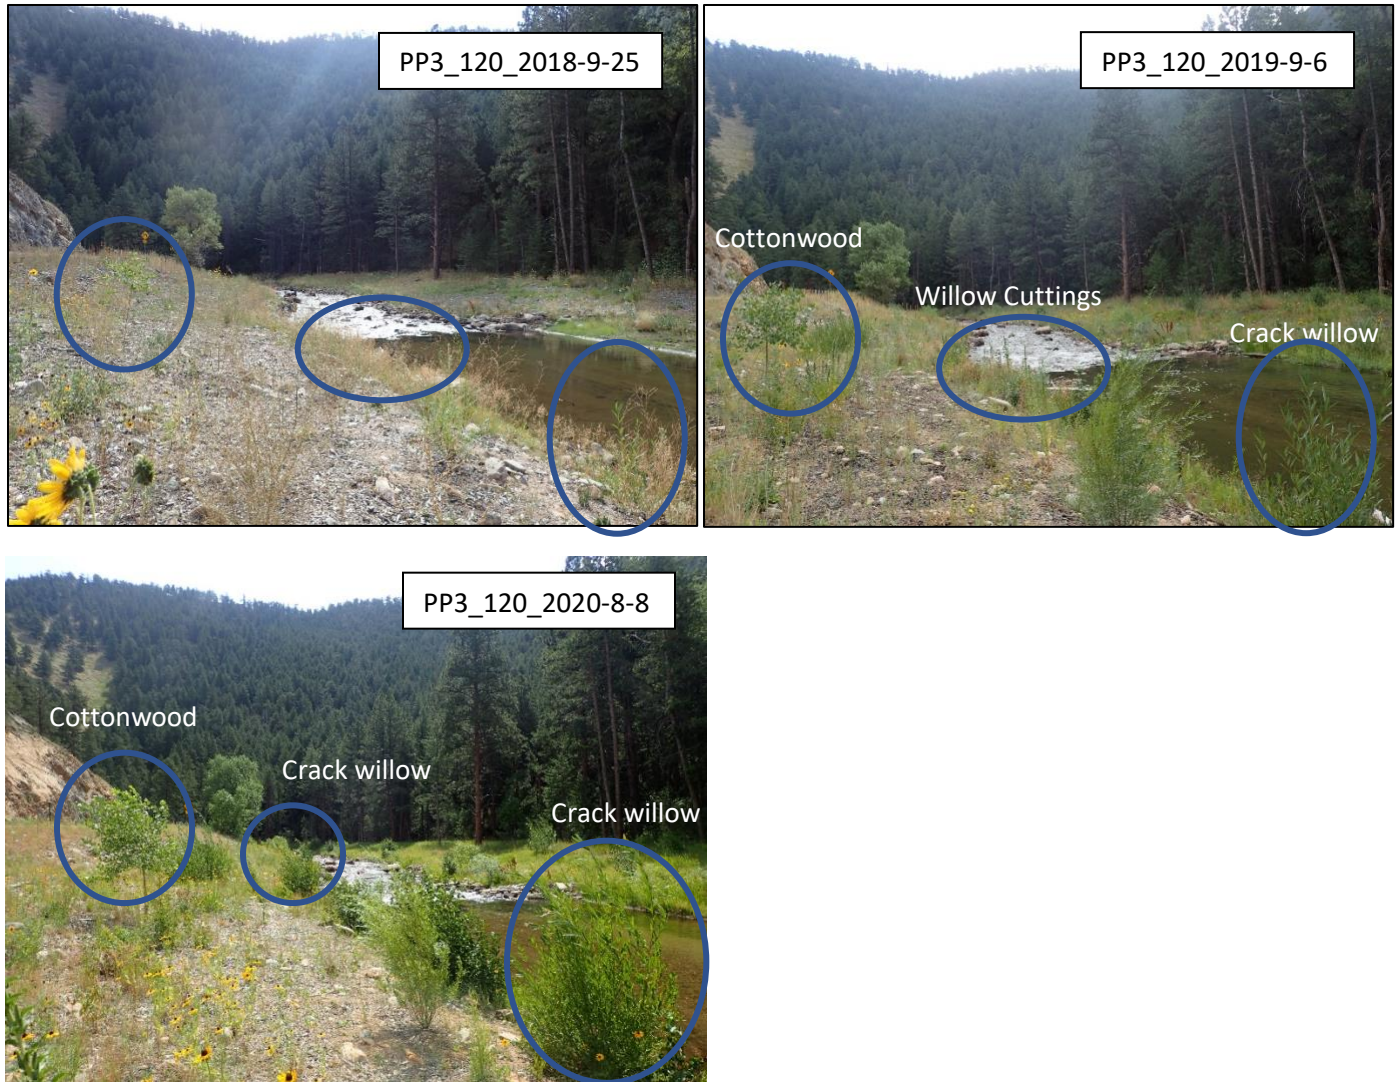
Lastly, we found persistent crack willow encroachment at the Upstream Buckingham site (Figure 15). This is a common concern at restoration sites, as crack willow is highly invasive and disperses through cuttings in the water.

Figure 15. Upstream Buckingham photo point 3 (PP3) photos from 2018 through 2020 on Left Hand Creek. This photo shows year to year growth of container stock (cottonwood), cuttings (coyote willow) and establishment of non-native crack willow

- Continued weed control on the Upstream Buckingham site to reduce non-native establishment, notably the crack willow.
