**PREDICTING THE RESPONSE OF WOODY RIPARIAN VEGETATION  
TO CHANGES IN INSTREAM FLOWS  
THROUGH INTEGRATED MONITORING  
OF STREAM HYDROLOGY AND RIPARIAN VEGETATION**

**PRELIMINARY REPORT**

**15 APRIL, 1991**

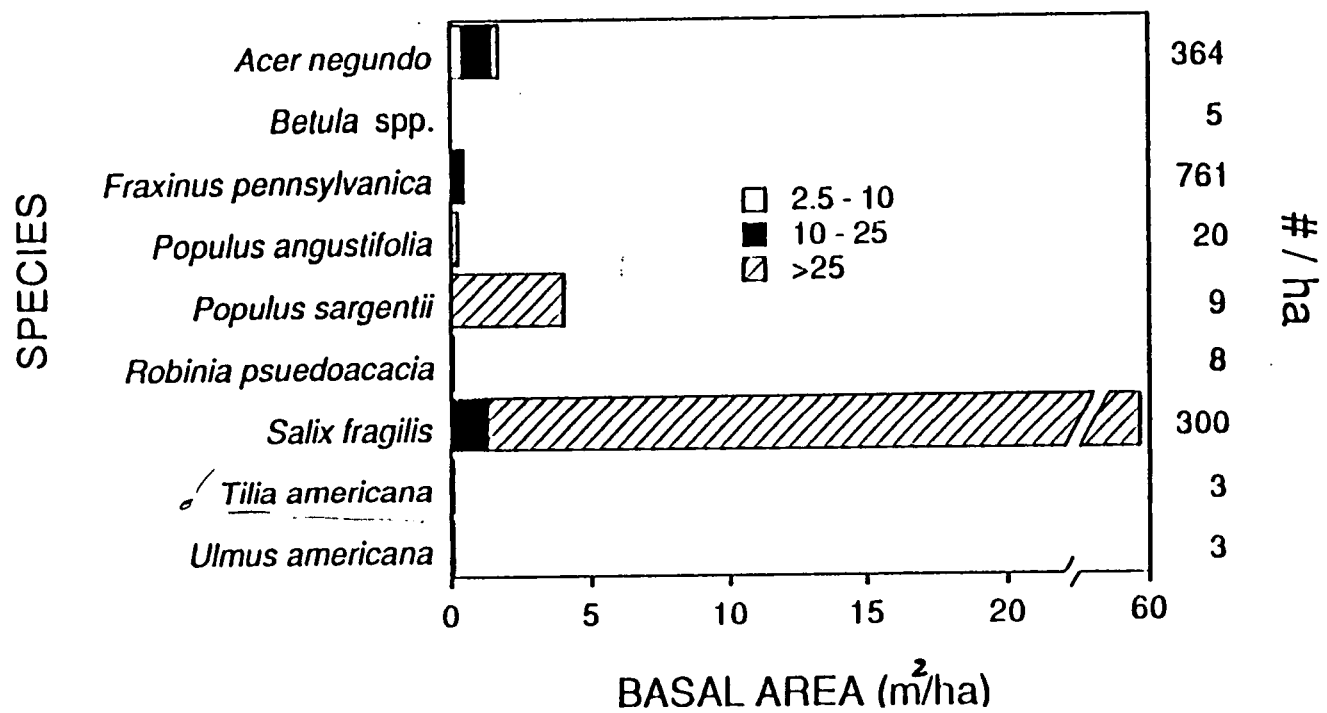
FIGURE 3.

Figure 3. Summary of basal area ( $m^2/ha$ ) and number of stems/ha, by size class, for all woody tree species sampled within 25m x 25m permanent vegetation plots in the upland alluvial bench area.

## Cottonwood Grove Alluvial Bench

A few large Plains Cottonwood (*Populus fremontii*) exist within the Cottonwood Grove, however, the stand is overwhelmingly dominated by the exotic tree species Crack willow (*Salix fragilis*) (Figure 3). The Crack willow in this stand may also be a hybrid between White willow (*Salix alba*) and Crack willow (W.A. Weber, pers. com.). We observed no reproduction by seed, rather, this species appears to persist vegetatively within the stand; this conclusion is based on the abundance of stems >25cm in diameter at breast height (dbh)

and the lack of stems <10cm dbh (see Figure 3). Cruz and Bock (1975), suggest that the Cottonwood Grove is dominated by plains and "narrow-leaved" Cottonwood; however, it is likely that what they were calling "narrow-leaved" Cottonwood was in fact what we are calling Crack willow, which upon superficial inspection might be confused with Narrowleaf Cottonwood (*Populus angustifolia*). Although we found both the Narrowleaf and the hybrid Cottonwood (*Populus* × *acuminata*) in the grove, they occurred in very low numbers.

Green ash (*Fraxinus pennsylvanica*) and Box elder (*Acer negundo*), which were likely rare historically, are important understory species in the grove (Figure 3). As on portions of the South Platte (Snyder 1987), Green ash may be gaining in importance in the grove, based on the large numbers of seedlings and small stems found in the upland stand (Figure 4).

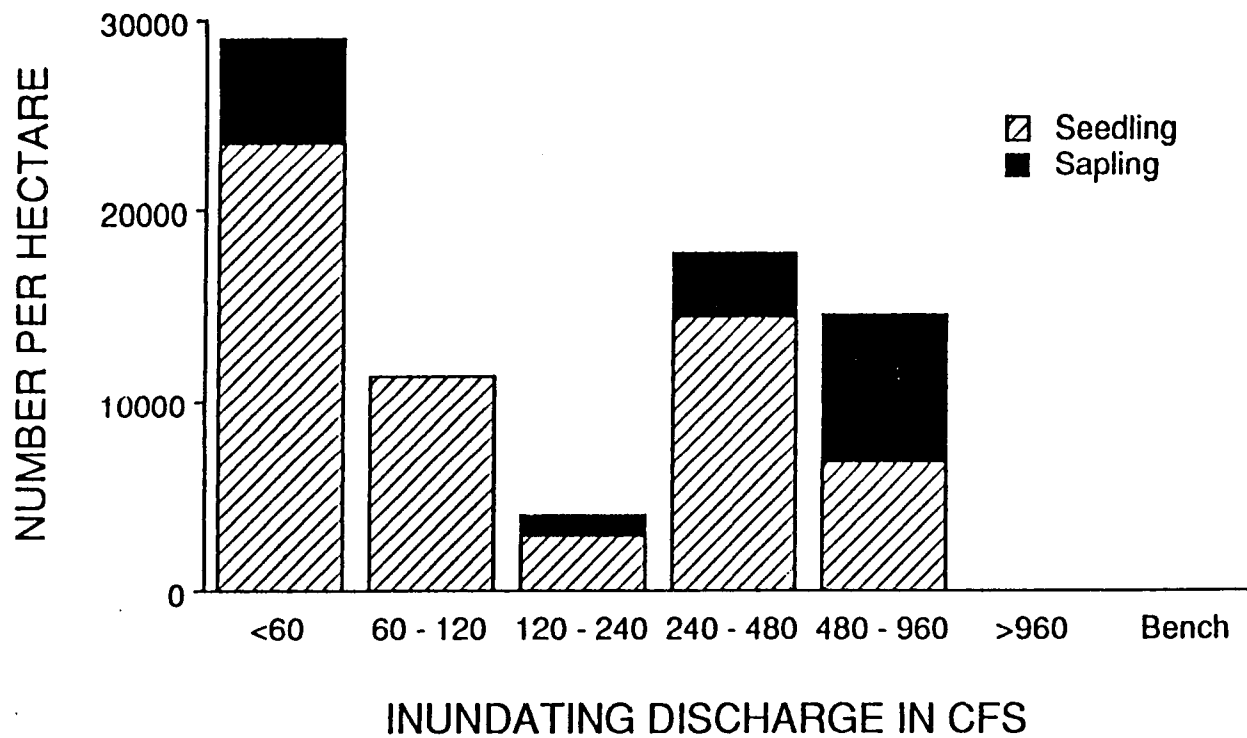
FIGURE 5.

Figure 5. Density (stems/ha) of Sand-bar Willow seedlings and saplings relative to the stream discharge (cubic feet per second) estimated to first inundate the plots in which the stems are found. All stems were sampled within permanent plots located within the active channel and along Instream Flow Incremental Methodology (IFIM) hydraulic cross-sections.

DISTRIBUTION OF  
SEEDLINGS AND SAPLINGS  
*Salix exigua*

The distributions of a number of woody species are interpretable in terms of site hydrology; for example, Sandbar willow seedlings and sprouts occupy frequently inundated sites next to the active channel whereas larger stems occupy less frequently inundated sites on forming floodplain surfaces or low elevation sites in overflow channels (Figure 5). In contrast, Cottonwood seedlings and saplings tend to occupy less frequently inundated sites (Figure 6). A few cohorts of saplings occupying relatively high elevation sites date to the high runoff year of 1983 (Figure 7). ✓

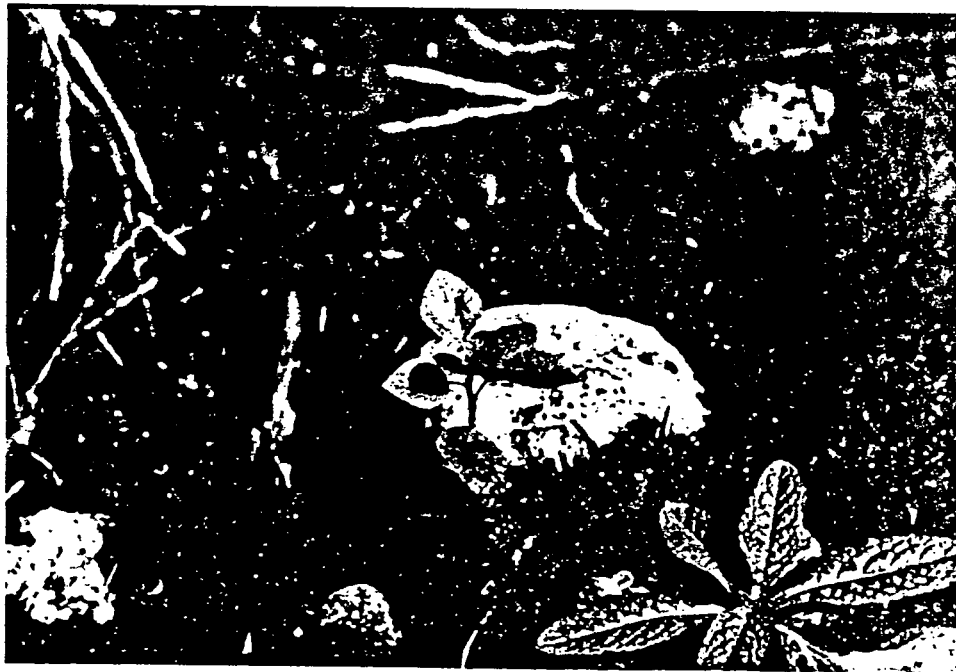
FIGURE 10.

Figure 10. A. A cohort of Plains Cottonwood saplings on a bar adjacent to the channel of Boulder Creek. Natural regeneration of native riparian species along Boulder Creek, and within the Cottonwood Grove now takes place in an incised, narrow active channel zone subject to surface-water inundation (see Figure 2). Successful establishment of cottonwood and other native riparian species is largely dependent upon the creation of fresh deposits of alluvial material following. B. A first-year cottonwood seedling on an open alluvial deposit that formed following the flooding in June of 1990.

We recorded no Cottonwood recruitment during the 1989 growing season, however, following the June flooding in 1990 (coincident with seed dispersal) we recorded extensive seedling establishment. Subsequent survival of seedlings was relatively low and was associated with sites having sparse cover and a relatively high seasonal water table (further analysis of Cottonwood seedling recruitment and mortality is in progress). These sites tended to occur on the lower edges of open gravel bars (see photos of seedlings, Figure 10a&b).
