TRAIL SYSTEM DETERIORATION
IN THE
BOULDER MOUNTAIN PARKS

FALL 1992

Connelly Brown, Chris O'Riley and Jay Sugnet

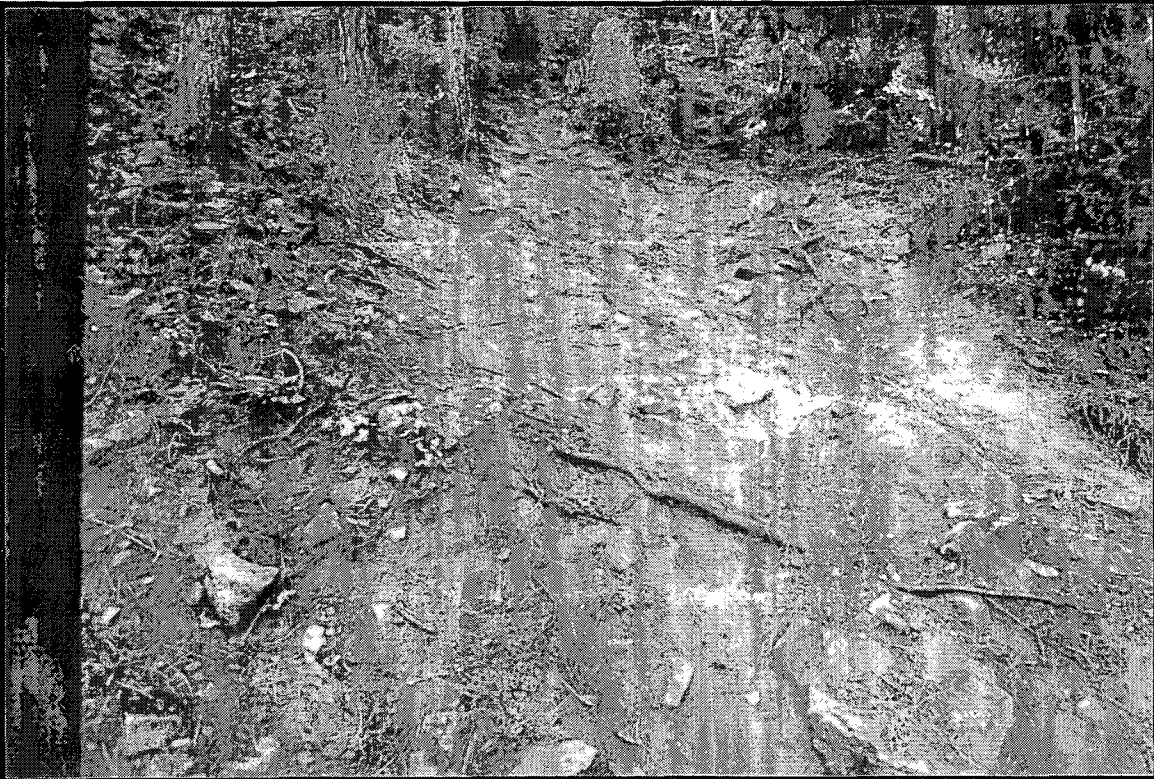
In the Amphitheater area, the most severe problem is an area of erosion beginning at the picnic table adjacent to the Gregory Canyon parking lot and traveling directly to the south (uphill) to the Amphitheater ([1] on map#1 and photo #1). This eroded trail is most probably used as a quick descent from the Amphitheater to Gregory Canyon as it is very steep with loose rocks and dirt and difficult to climb up. It is approximately 60 feet wide for most of its length and 80 to 100% denuded of ground vegetation. Trees are still in abundance, but have many exposed roots. There are also several social trails heading directly west from the Amphitheater trail directly up to the Amphitheater.

PHOTO #1: Erosion between Gregory Canyon and the Amphitheater, looking south.

1) Close the eroded trail from the Gregory Canyon parking lot to the Amphitheater ([1] on map #1). A rail post fence should be constructed at the base of this trail near the picnic table to keep people from going up to the Amphitheater. However, since most people appear to use this trail as a descent, some sort of deterrent

Trail
 needs to be placed at the top near the Amphitheater itself. A rail post fence at this juncture seems like an extreme measure, but it may be the only way to keep people from using this trail as a descent. There should be information posted on these fence barriers stating that the reason for them being there is to stabilize and revegetate the area. All smaller social trails in the Amphitheater area should be closed with brush and slash and have information signs posted on the reasons for such closure.

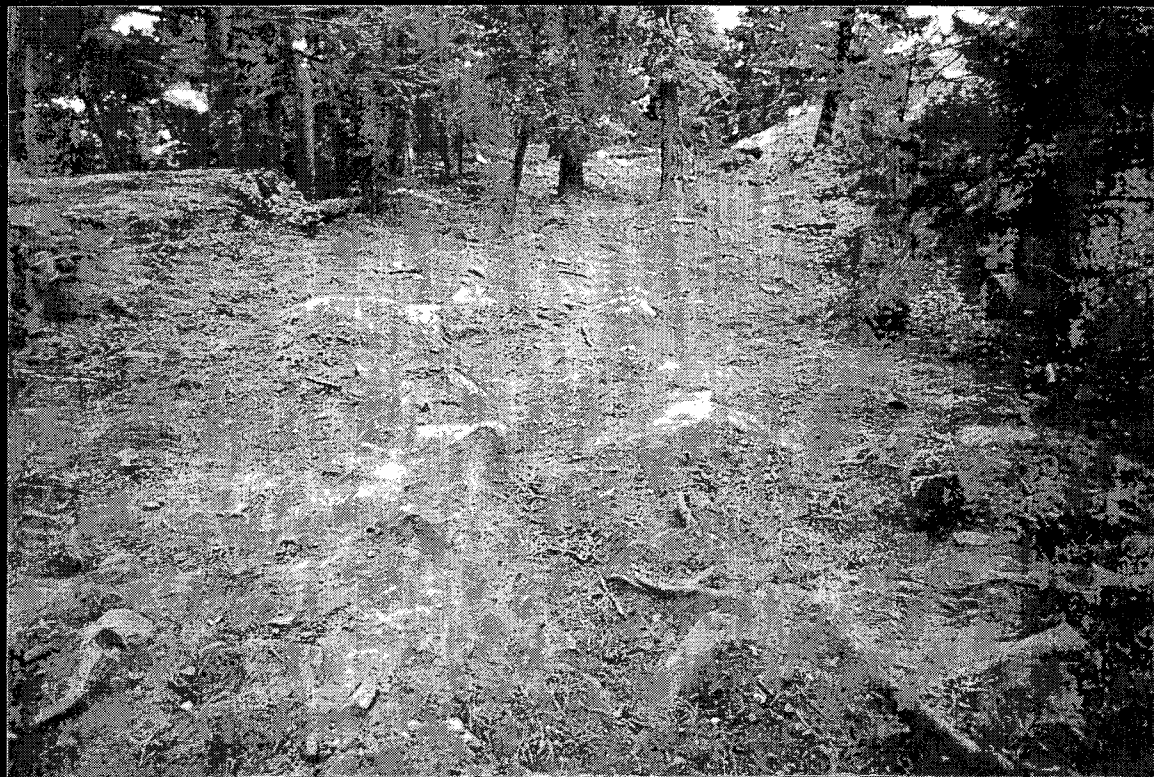
Trails leading to both the First and Second Flatirons begin from the Bluebell-Baird trail a short distance south of the intersection of the Bluebell- Baird trail and the Chautauqua trail. This is also about 600 feet north of the Bluebell Shelter on the Bluebell-Baird trail ([5] on map#1). The First Flatiron trail splits off from the Second Flatiron trail and heads west between the First and Second Flatirons. This area between the First and Second Flatirons, from their base to their top, was recently developed as an official trail, but is now severely eroded with little resemblance to a well developed official trail ([6] on map#1 and photos #2 and 3). There are two separate areas of erosion with one close to the south side of the First Flatiron and one on the north side of the Second Flatiron. Both areas are almost totally denuded of ground vegetation and are at points 50 to 60 feet wide. This area appears to be the most heavily eroded area in the Flatirons ⁴⁰² and deserves immediate attention. *

PHOTO #2: Wide area of erosion between the First and Second Flatirons, looking east.

1) The official First Flatiron trail should be developed through the area of erosion between the First and Second Flatirons and should connect with the Climbing Access trail at the west bench of the First Flatiron. This will create a loop, something many hikers like, around the First Flatiron from the Bluebell-Baird trail to the Saddle Rock trail. This trail will also give access to the top of the Second Flatiron. The remaining eroded areas should be closed and revegetated.

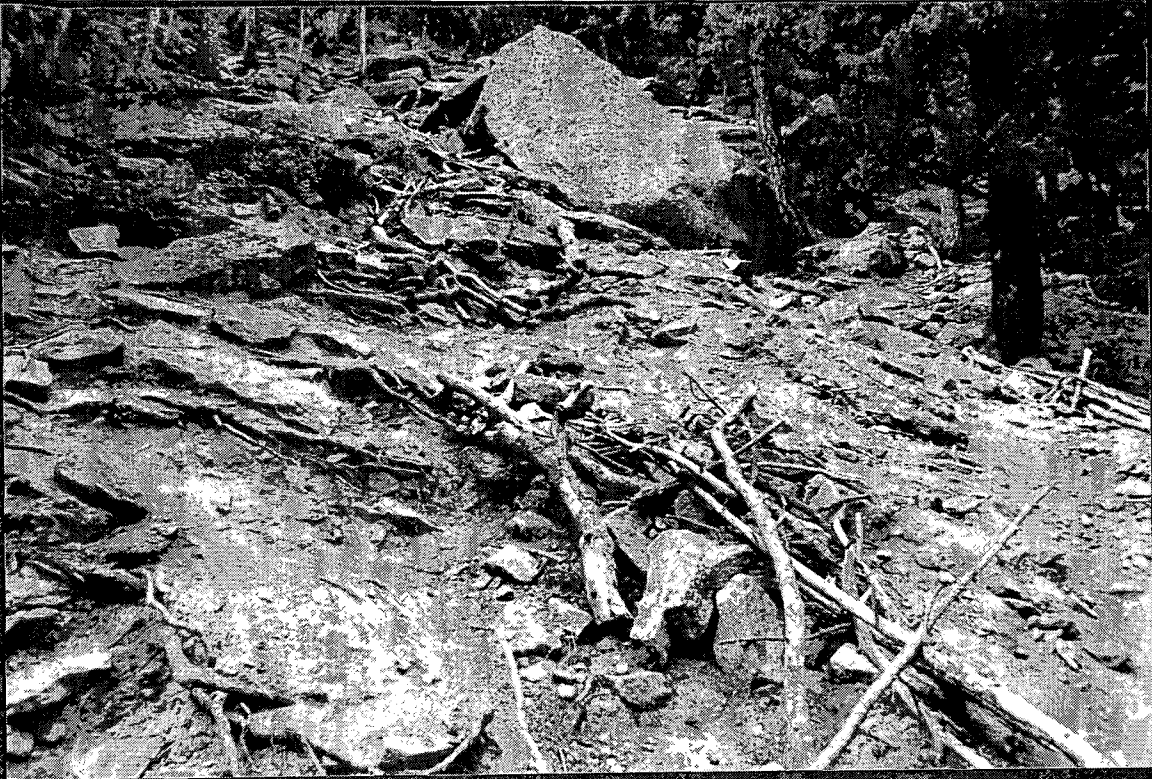
PHOTO #3: Erosion between the First and Second Flatirons, looking west.

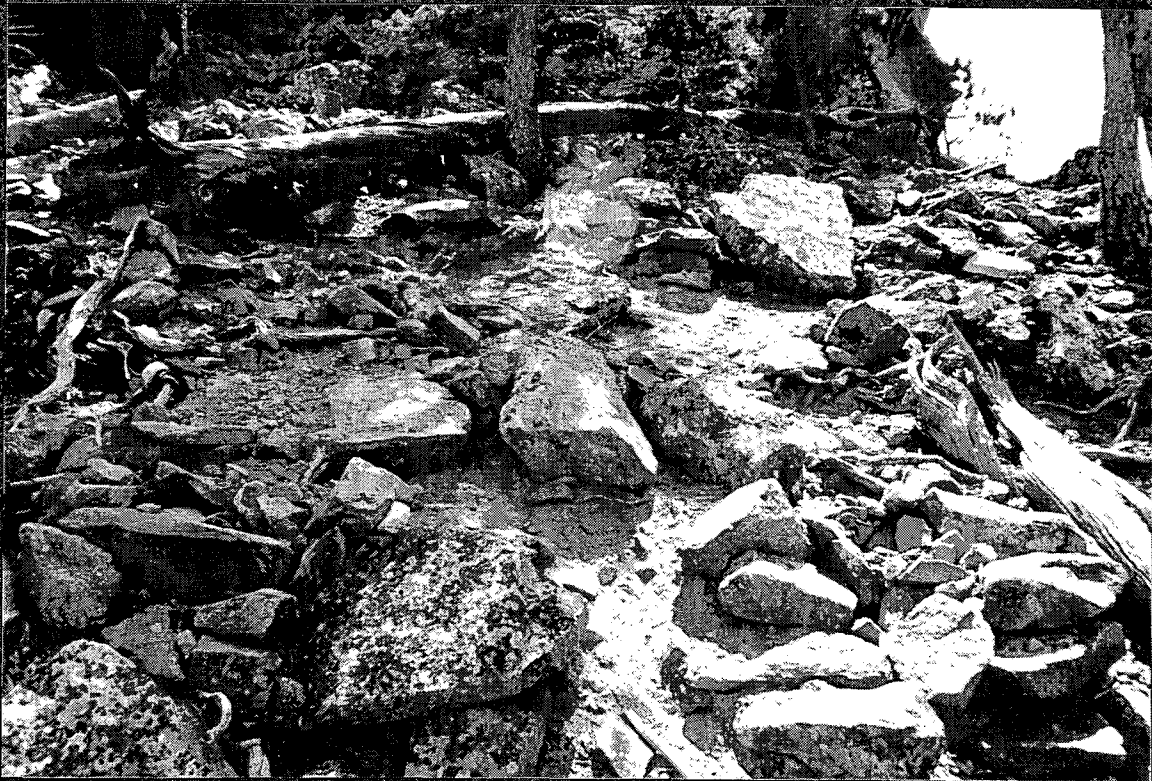
There are also wide areas of erosion leading from the west bench of the First Flatiron down to the west bench of the Second Flatiron and surrounding Sunset Rock just west of the First Flatiron ([7] on map#1 and photo #4).

PHOTO #4: Northwest side of Sunset Rock near the First Flatiron.

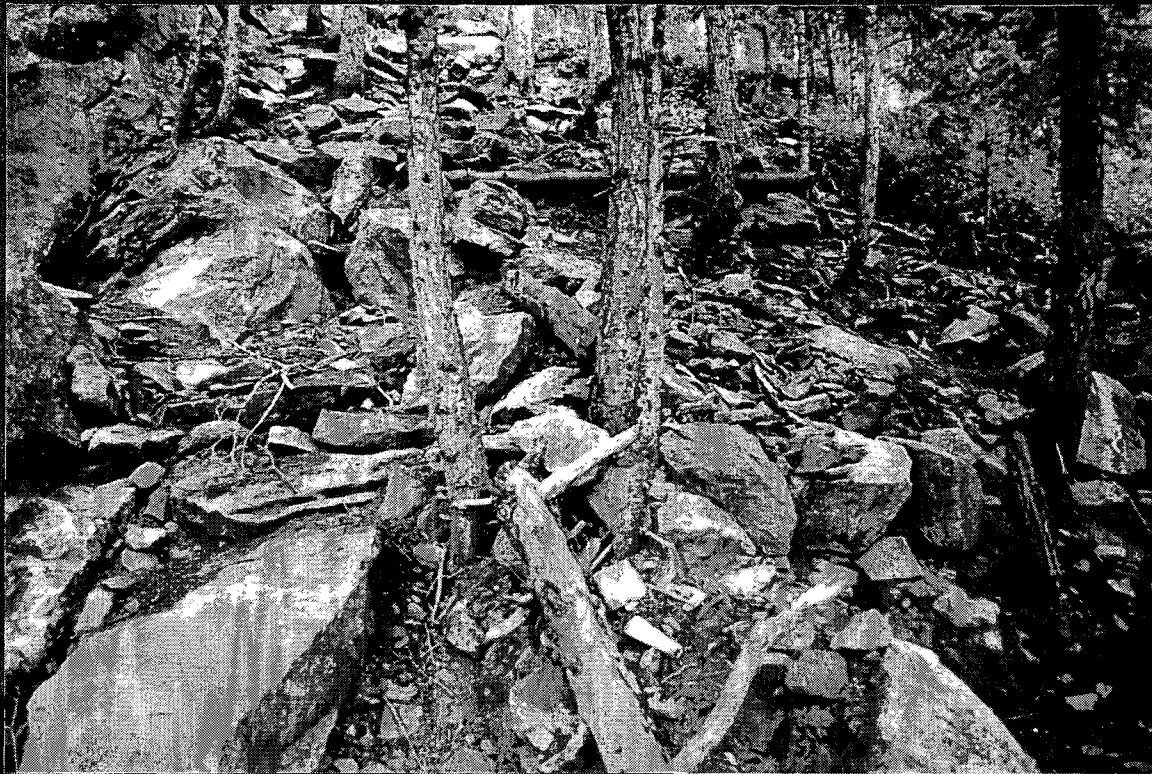
An official trail from the Bluebell Shelter to both the east and west benches of the Third Flatiron is currently nearing completion. Hopefully this will funnel hikers away from the eroded area on the north side of the Third Flatiron ([11] on map#1 and photo #5). This eroded area is up to 100% denuded of ground vegetation and up to 50 feet wide. The new trail proceeds up a talus slope to the north of the erosion and will hopefully allow this damage to be re vegetated. In some places the Third Flatiron trail intersects with large social trails and it is difficult to know where the official trail is.

PHOTO #5: Eroded area on the north side of the Third Flatiron, near the top, looking west.

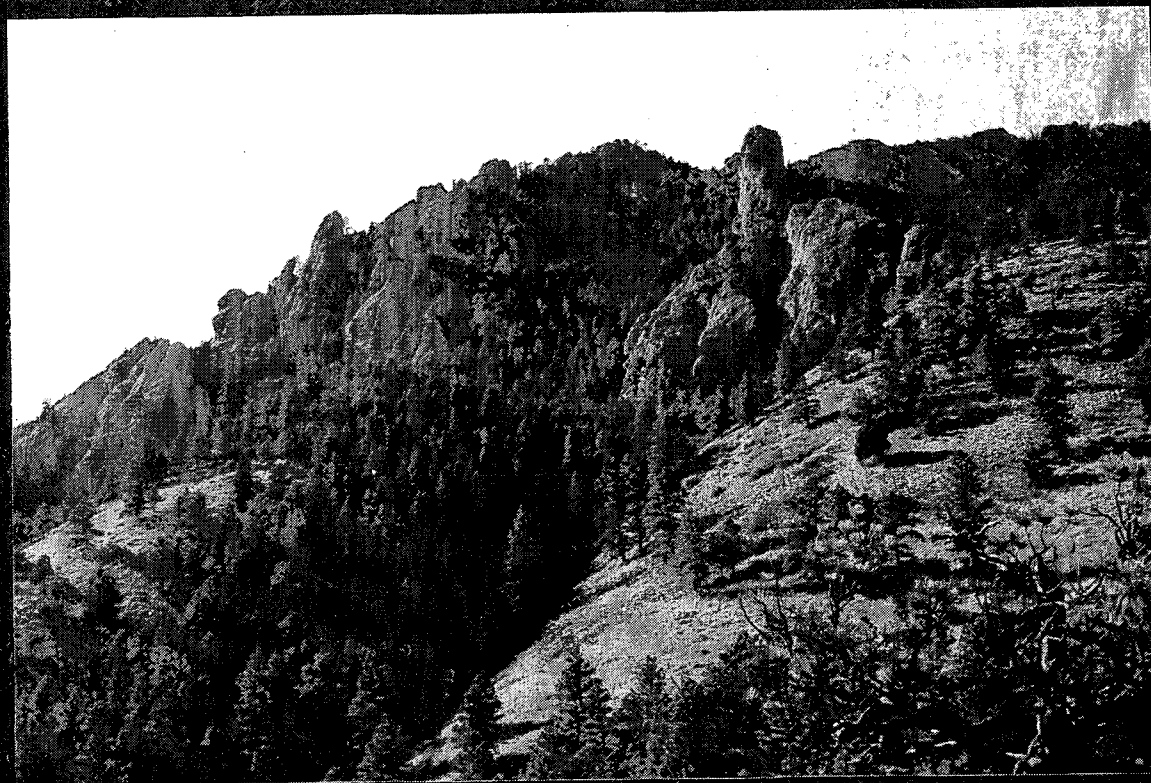
Introduction: Dinosaur Mountain is a relatively small area with a plethora of rock, making it an ideal area for rock climbing. However, the terrain is rather steep and prone to erosion as witnessed by the existence of a trail between almost every rock formation. Due to the steep grade of the slopes, the majority of people using the social trails are rock climbers accessing routes, with very few hikers. With the moratorium on bolting in effect, I do not anticipate any further trail formations, but the existing trails are receiving more use and experiencing greater erosion. This is especially true since wildlife closures in other areas attract climbers to Dinosaur Mountain. See area photo #6.

PHOTO # 6: Overview of Dinosaur Mountain.

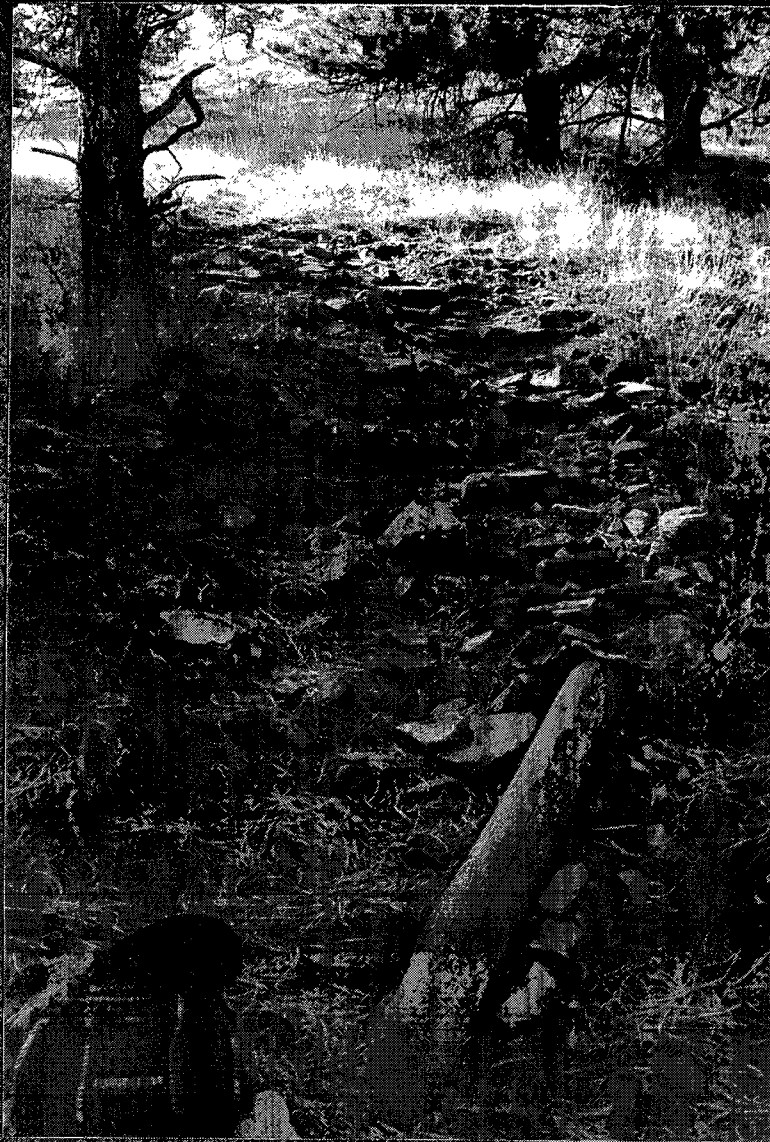
Mallory Cave Trail is the only official trail penetrating Dinosaur Mountain, it handles most of the use in the area and has been greatly improved over the past five years, but a few problems remain. Two areas in the lower extent, as indicated on the map, are relatively steep and in the case of rain, muddy. This has caused people to widen the trail to avoid the mud; a few water bars are recommended. See photo #7.

PHOTO #7: Trail migration on the Mallory Cave Trail.

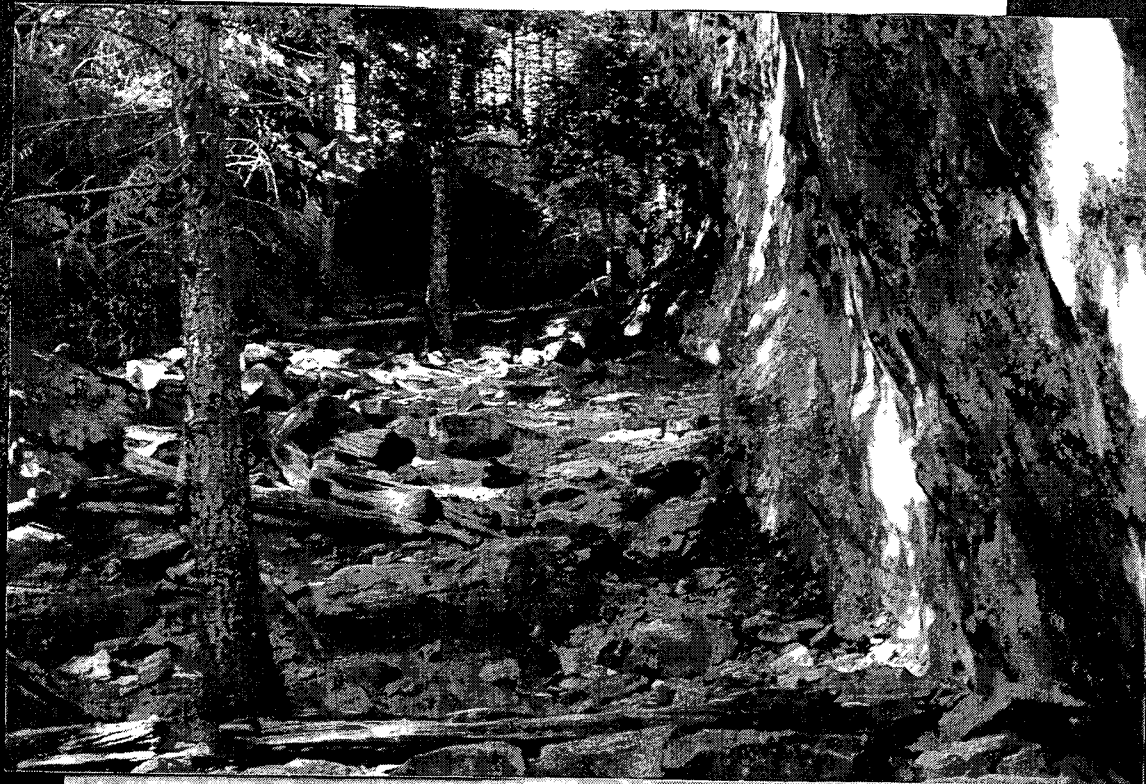
Climbers also contribute to erosion *off* the trail in a popular area on Der Zerkle by the climb 'The Final Solution.' This area has been 90% devegetated by as many as a dozen people waiting in line to climb the three bolted routes and a bouldering traverse. See photo

#8. The same situation has occurred in 'The Court' on the west side of Der Zerkle where many other classic bolted climbs exist. *Some questions on map: 13*

PHOTO #8: Climbing area with 'The Final Solution' to the right.

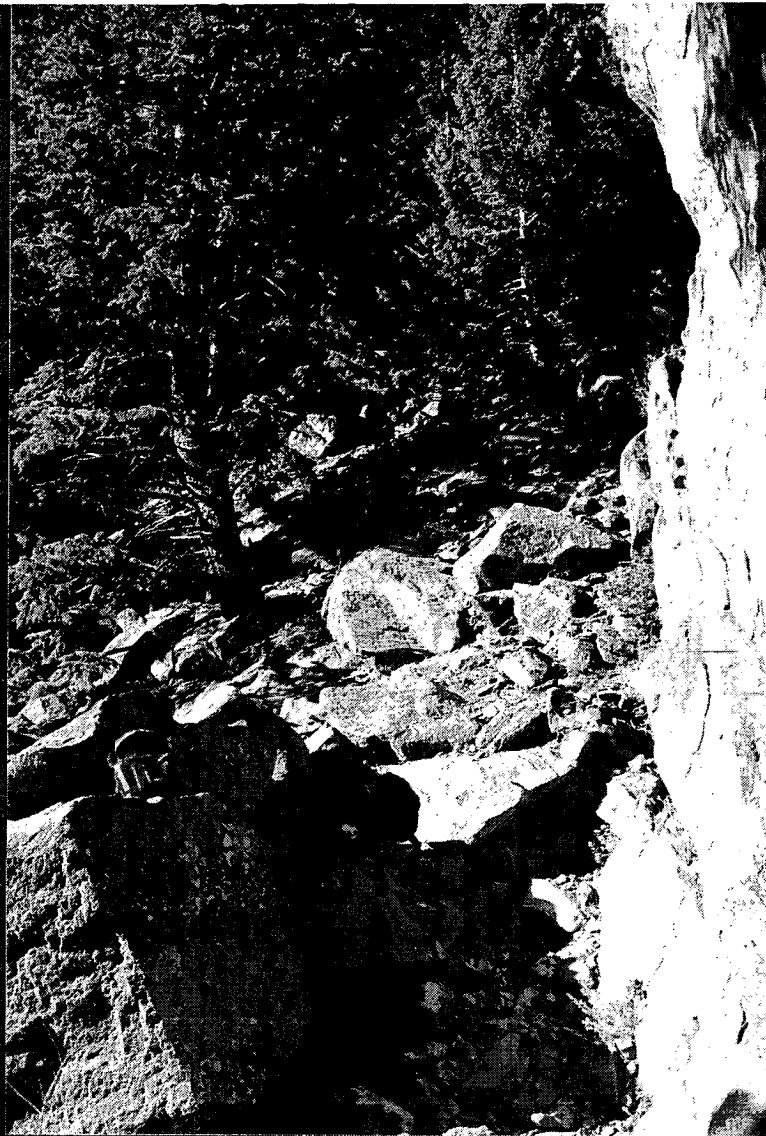
scree. A sign at the base indicating 'closed for revegetation' is recommended since it is also a dangerous area to hike. The trail continues up to two climbs on a small hogback called Hueco Wall. This area has some of the worst erosion I witnessed on Dinosaur Mountain, and is directly attributable to climber activity. See photo #9. Many roots of trees have been exposed and their survival has been threatened. See photo #10. I don't normally advocate the removal of routes, but this area is an exception. The only alternative would be to place a trail leading from the west side of Bear Creek Spire, the condition of which has been described above, to Hueco Wall.

PHOTO #9: Hueco Wall area.

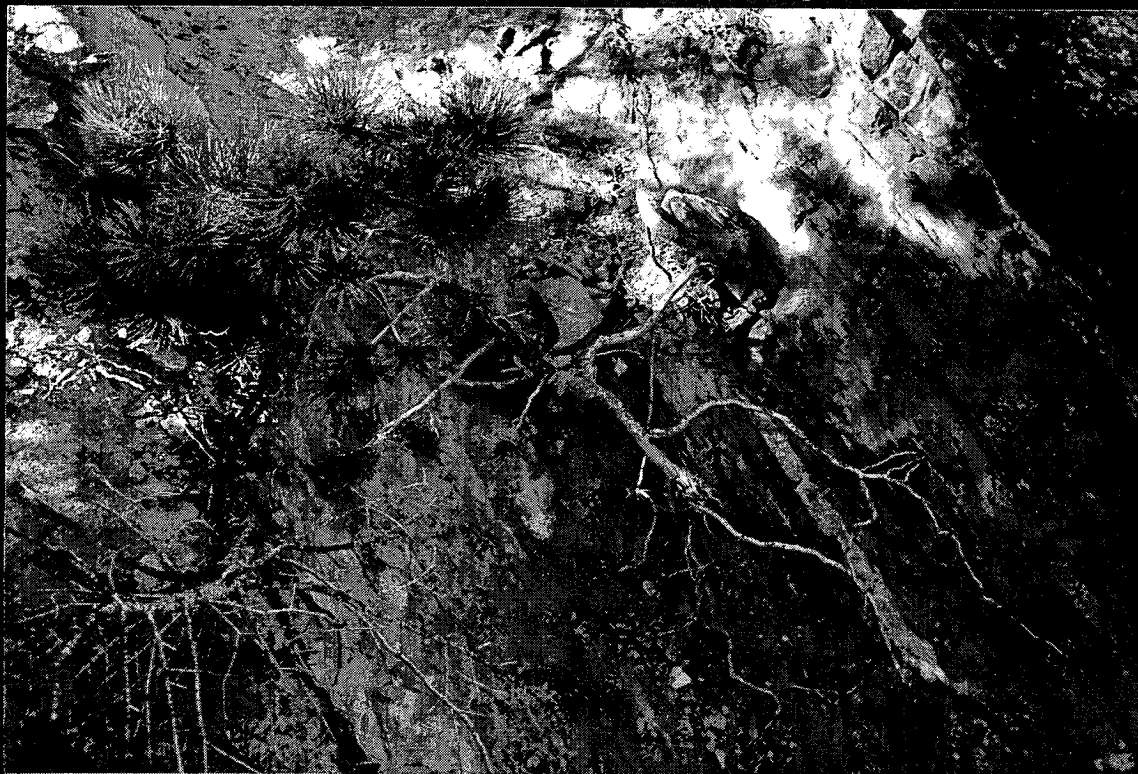
PHOTO #10: Exposed roots of a tree under Hueco Wall

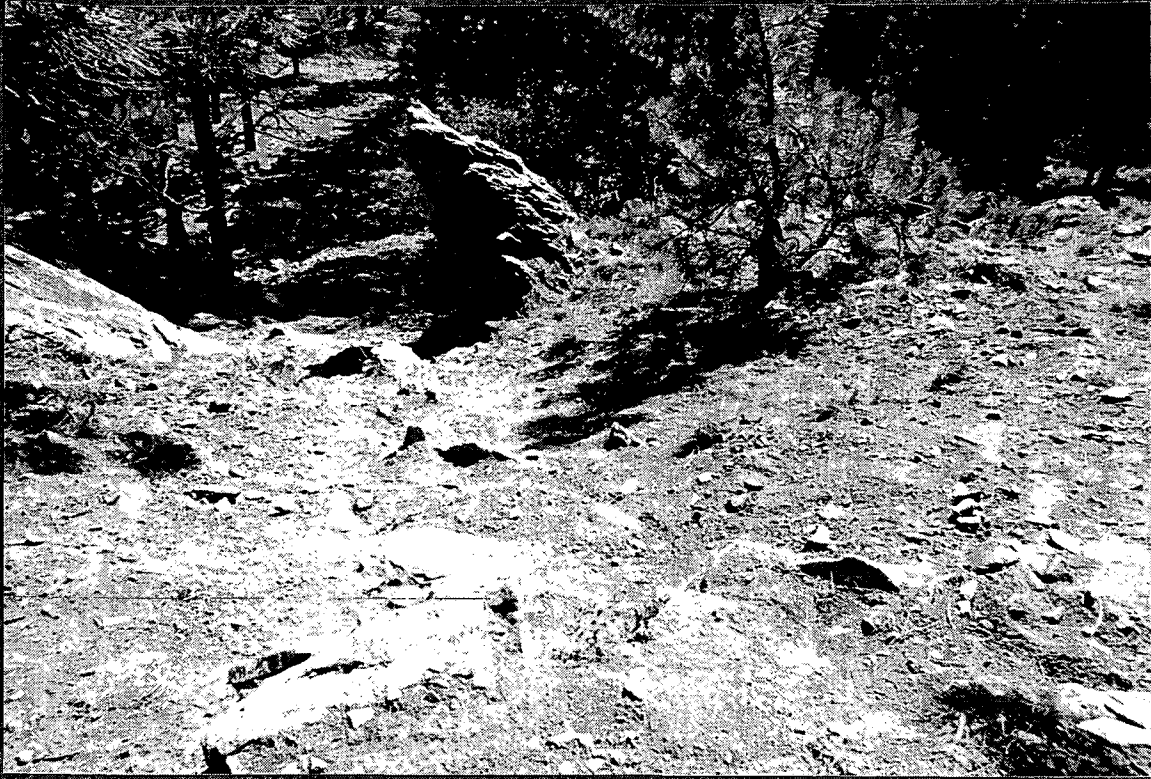
Between the First and Second Flatiron trails there is an extensive network of braided trails and erosion which has the potential to develop into more severe erosion ([10] on map#1). These braided trails appear to be used as an ascent by people trying to get

PHOTO # 11: Eroded social trail directly west of the juncture of the First and Second Flatiron trails, looking east.

2) The area of braided trails between the First and Second Flatiron trails should be closed. A fence may be needed where many of these trails leave the Second Flatiron trail ([10] on map#1).
