**State of the Watershed Report 2019:  
Adaptively Managing a Working River in a  
Recovering Watershed**

**May 2019**

**LEFT HAND WATERSHED CENTER**  
6800 Nimbus Road, Longmont CO 80503 (office)  
P.O. Box 1074, Niwot, CO 80544-0210 (mailing)  
303.530.4200 | [www.watershed.center](http://www.watershed.center)

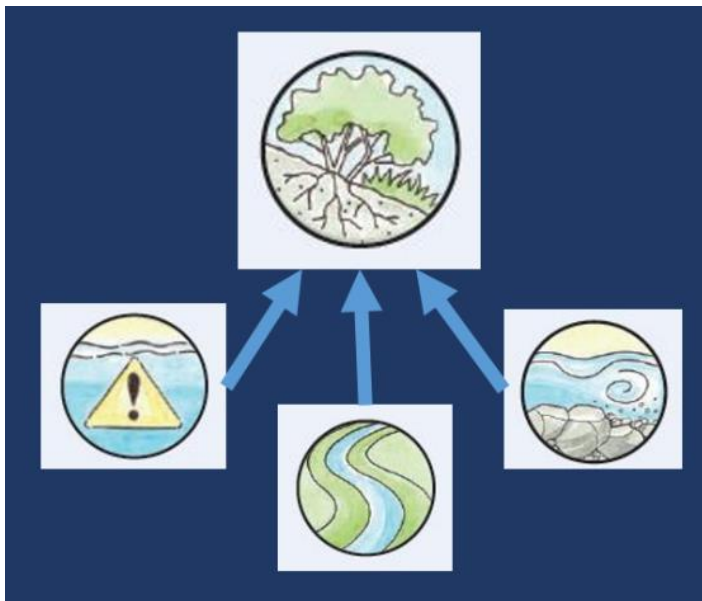
Figure 1. Our updated Monitoring & Assessment Framework assesses ecological parameters as indicators of overall watershed function.

To address this, we've recently updated our adaptive management framework to address flow regime, stream form, and sediment regime as drivers of the ecological community (Figure 1). This will allow us to assess our trajectory towards resilience based on the trajectory of the ecological community, and explain ecological function based on the performance of other key watershed functions.

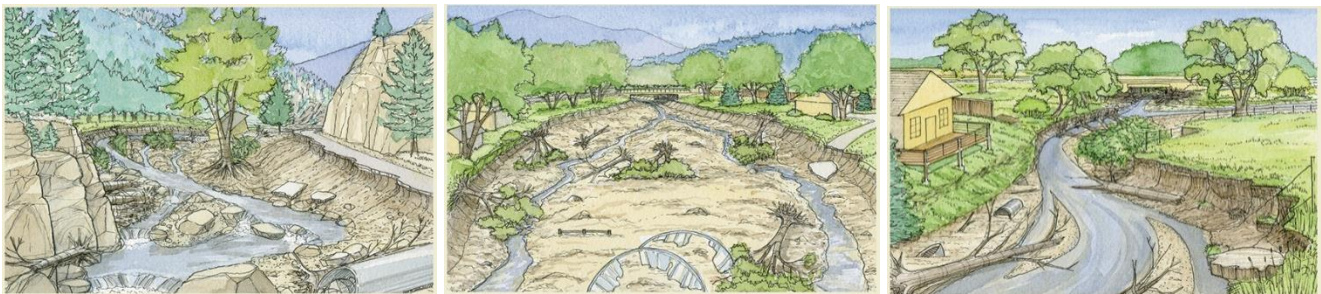
### Post-Flood

In 2013 extensive flooding due to three plus days of heavy rain caused another dramatic transformation to all Front Range Watersheds, including Left Hand Creek. High peak flow and sediment/debris inputs caused the creek to migrate and experience deposition, erosion, and loss of riparian vegetation and habitat. Debris flows and eroded hillslopes in the upper watershed delivered a substantial quantity of sediment and debris to the alluvial fan and plains areas. This high sediment load quickly plugged crossings, resulting in wide-spread sediment deposition, channel avulsion, and substantial bank erosion. Much of the agriculture, lawns, and infrastructure were damaged or destroyed when high flows reconnected the creek to its floodplain. Invasive crack willow (*Salix fragilis*) encroachment was also reduced in some areas where the high flows felled trees adjacent to the banks. Water quality and aquatic communities declined compared to pre-flood as a result of sediment pulses from mine tailings in the upper watershed, substantial bank and floodplain erosion, and a loss of aquatic and riparian habitat.

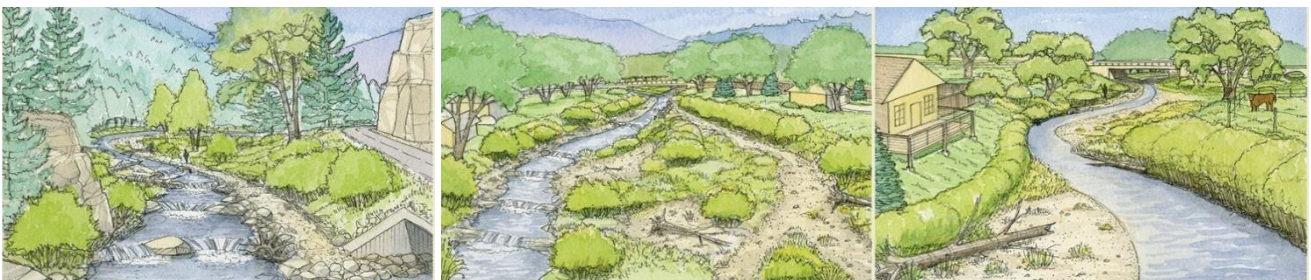
### Today and Our Future

Today our watershed continues to change and evolve as it recovers from the 2013 floods. We are managing this recovery using an adaptive approach. Our approach is described in detail in our [Adaptive Management Guide](#),

available on our website. As part of this process we (1) conceptualized a desired future for our watershed which aims to maximize resilience within the reality of a working river; (2) developed a framework for monitoring our trajectory towards resilience; (3) implemented flood recovery restoration projects throughout the watershed to jumpstart the process of building resiliency and directing watershed functions towards the desired future condition; and (4) evaluated our trajectory towards resilience by monitoring and assessing key watershed functions.

As we conceptualize the resilient future of our watershed, we envision a watershed with a healthy riparian community and robust aquatic habitat created and maintained by good floodplain connectivity and dynamic geomorphic and ecological processes. We also envision room for the creek to move and adjust, in order to allow dynamic river processes to occur and diverse, ever-changing, riparian habitat. Leveraging lessons learned from looking at our history we knew that we must avoid a “locked-in” creek dominated by invasive crack willow (*Salix fragilis*), and that this would likely require on-going maintenance because of a lack of flushing flows. Recognizing that intermittent flows will always be a reality in our working river, we considered solutions to alleviate the impacts of diminished flows on watershed health and looked for multiple benefit opportunities whereby benefits to watershed health also benefit functions of ditches and diversions.

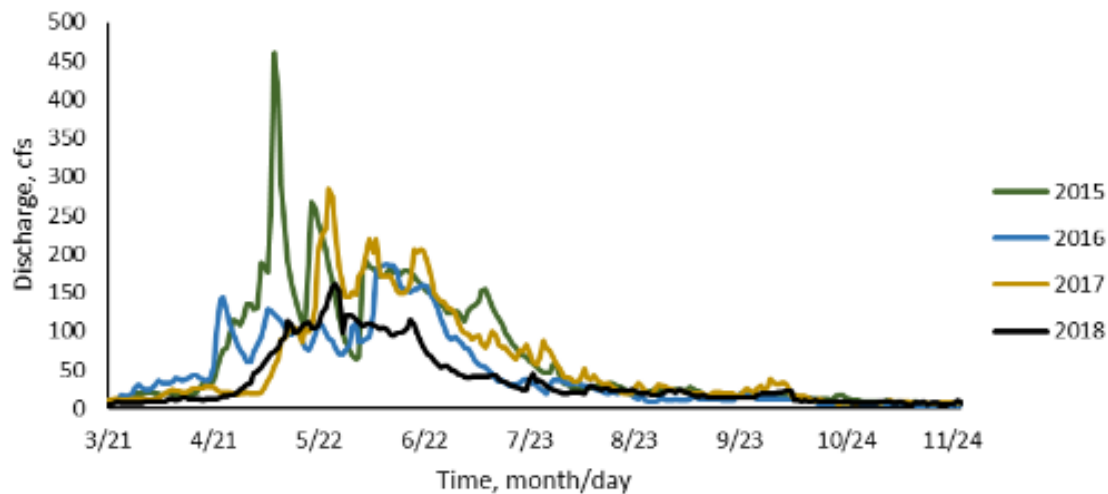
**Figure 4.** Annual discharge from March through November from 2015-2018 at the Colorado Division of Water Resources LEFTCRECO stream gage on Left Hand Creek, Boulder County, CO. The gage is located upstream of the Allen Lake diversion.

- Like other streams in the Front Range, Left Hand Creek is a snowmelt system with a peak springtime flushing flow associated with snowmelt. In 2018, we did not reach peak flushing flows typical to recent years due to drought conditions.
- After runoff, water downstream of the Allen's Lake diversion is diverted for agriculture and instream flow below the diversion is not reflected in this hydrograph.
- As a result of diverting water, lower flows may not properly transport sediment below diversions or inundate the floodplain or appropriate benches, as desired.
- Drought conditions further impact lower flows in the summer and fall, resulting in dry periods and encroachment of vegetation into the channel.

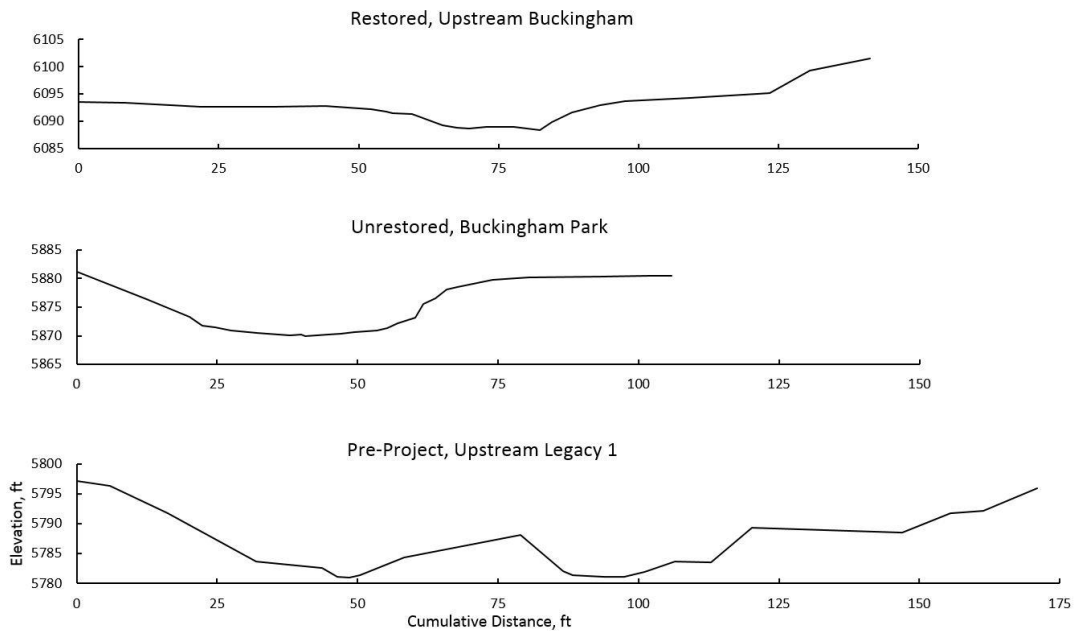
**Figure 5.** Representative cross sections from 2018 monitoring of a restored, unrestored, and pre-project site in the canyons of Left Hand Creek, Boulder County, Colorado.

- It is important for creeks to have access to floodplains throughout the year to allow for natural occurrence of dynamic fluvial geomorphic processes.
- As demonstrated in the restored and pre-project cross sections, the 2013 floods either cut down channels or deposited excess sediment and debris that detached the creek from its floodplain.
- Restoration projects reconnected floodplains that were designed to be inundated at peak flows throughout the watershed.
- As demonstrated in the restored site cross section, restored sites maintained broader floodplains one year after restoration.

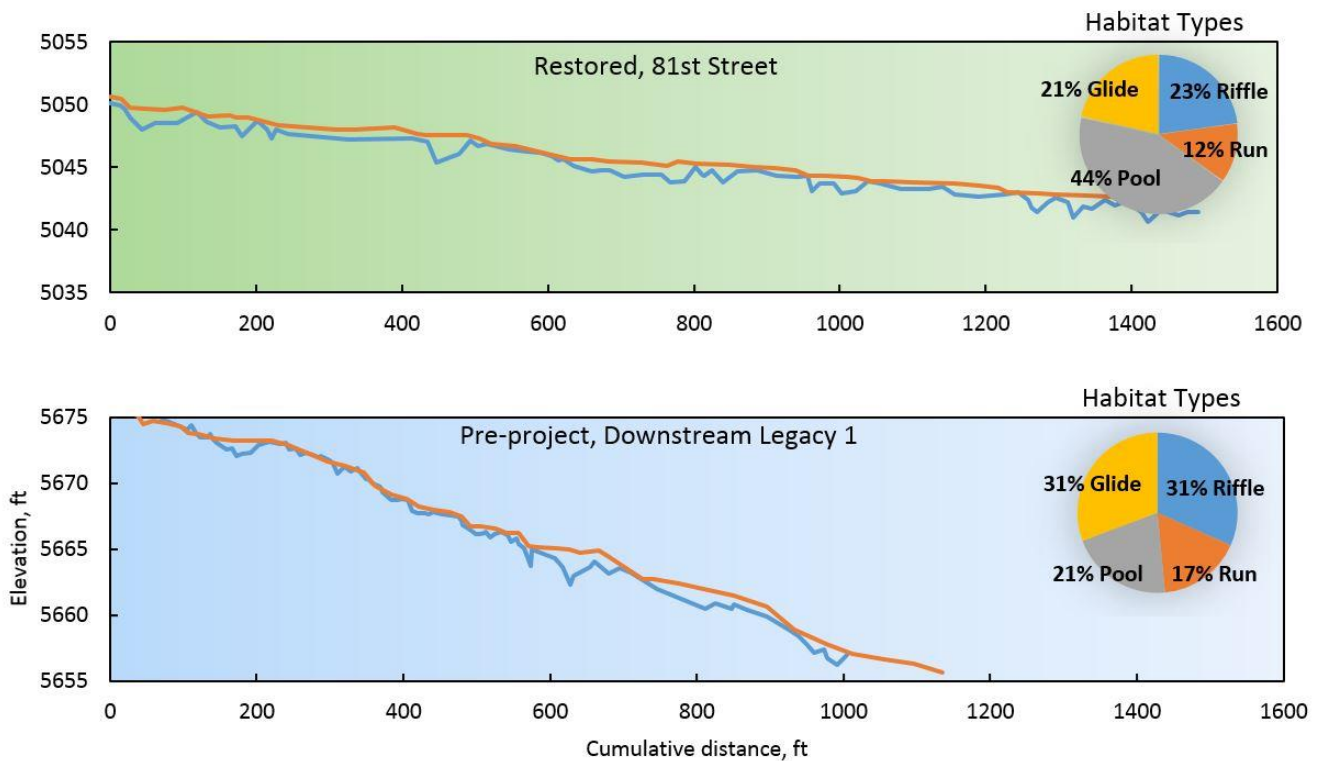
**Figure 6.** The 2018 longitudinal profile for a representative restored and unrestored reach in Left Hand Creek, Boulder County, Colorado. Water surface and bottom along the thalweg indicated by orange and blue lines, respectively.

- Pool habitat and pool/riffle sequences are important habitat types for fish and invertebrates.
- As demonstrated in the pre-project longitudinal profile, post-flood channels were lined with debris and had fewer pools and embedded riffles.
- Restoration projects removed larger debris and established pools and riffles with appropriately sized substrate.
- As demonstrated in the restored longitudinal profile, pool habitat was greater at restored sites than pre-project sites and pool/riffle sequences were retained at restoration sites one year after restoration.

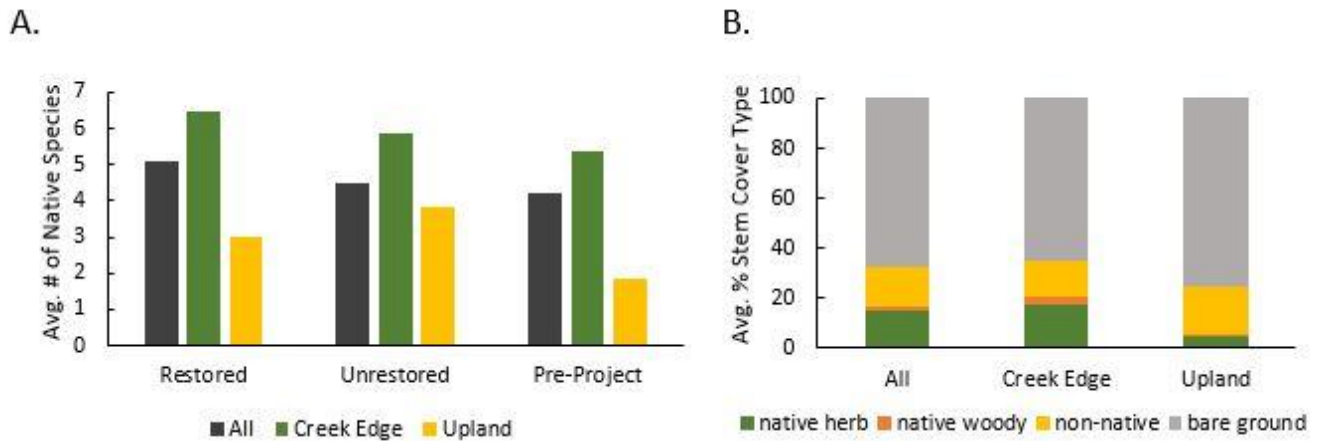
**Figure 7.** The 2018 riparian vegetation summary for (A.) average native species richness in riparian zones for all restored, unrestored, and pre-project sites and (B.) average percent cover type in riparian zones at all restored sites in Left Hand Creek, Boulder County, Colorado.

- Diverse native species composition provides resilience and habitat for fish and wildlife.
- Restoration projects seeded riparian areas from creek edge to upland zones with native species.
- In 2018, restored sites had greater average native species richness (A.) compared to unrestored and pre-project sites. The greatest average native richness for all sites was found at creek edge.
- Similarly, average percent native cover (B.) at restored sites was greatest along creek edge compared to upland zones.

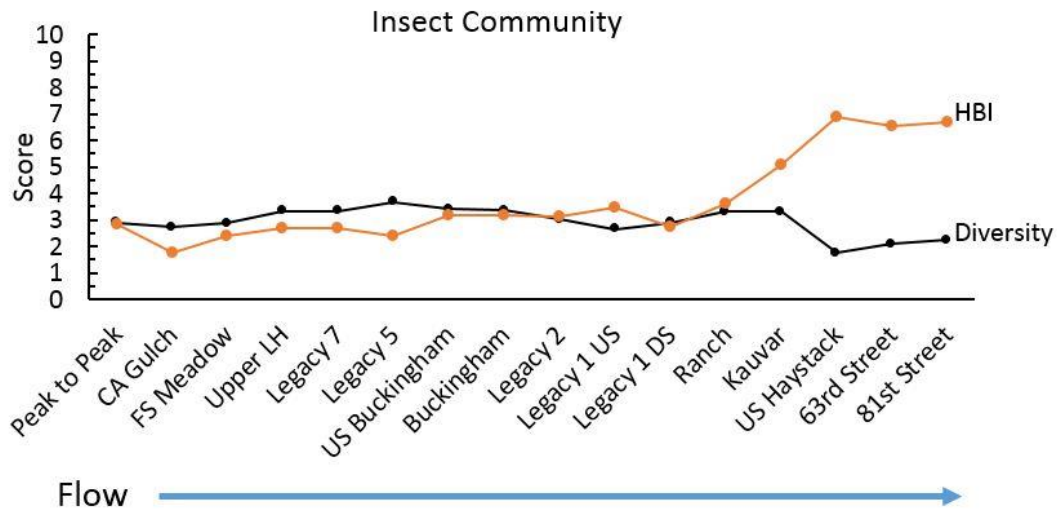
**Figure 10.** The Shannon Diversity and Hilsenhoff Biotic Index (HBI) for 2018 BMI community samples in Left Hand Creek, Boulder County, Colorado. The greater the diversity score, the more diverse the community, the greater the HBI score, the more tolerant the community is to water quality impairments. Sites are arranged upstream to downstream.

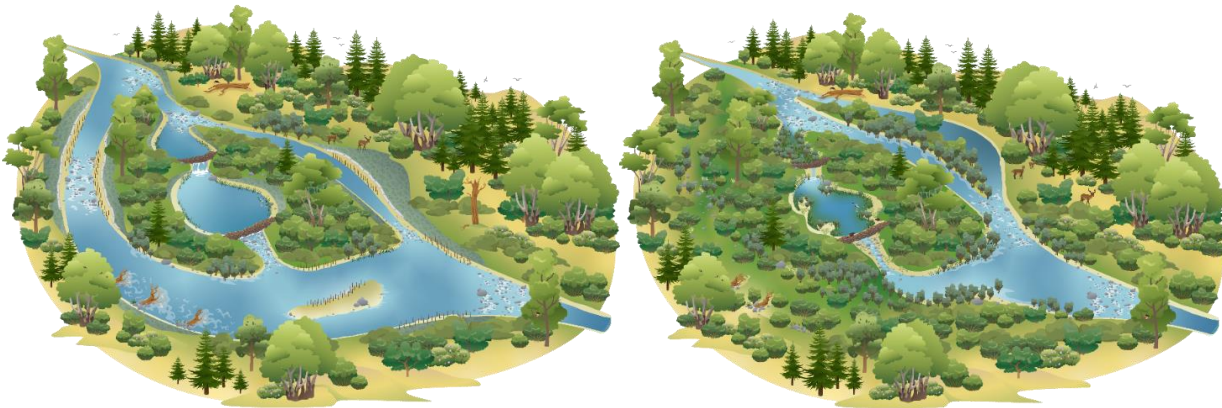
**Restoring to the Future:** Cluer and Thorne's SEM also describes that optimal ecosystem benefits will be achieved in depositional reaches with a dynamic multi-thread stage zero channel with a broad floodplain and complex habitats to support long-term resiliency. Based on this recommendation, we are using this approach at one of our 2019 restoration projects and setting up an adaptive restoration experiment to quantify the ecosystem benefits of a stage zero channel. Above, the rendering on the left shows a stage zero restoration one year after project completion. The rendering on the right shows just one (of many possible) potential futures for a stage zero site multiple years after restoration.
