**CITY OF BOULDER FUNDED RESEARCH PROGRAM**

**Final Report:**

**Restoring for resilience: Assessing the restoration success of flood recovery projects on Left Hand Creek, Boulder County, Colorado**

**LEFT HAND WATERSHED CENTER**  
6800 Nimbus Road, Longmont CO 80503 (office)  
P.O. Box 1074, Niwot, CO 80544-0210 (mailing)  
303.530.4200 | [www.watershed.center](http://www.watershed.center)

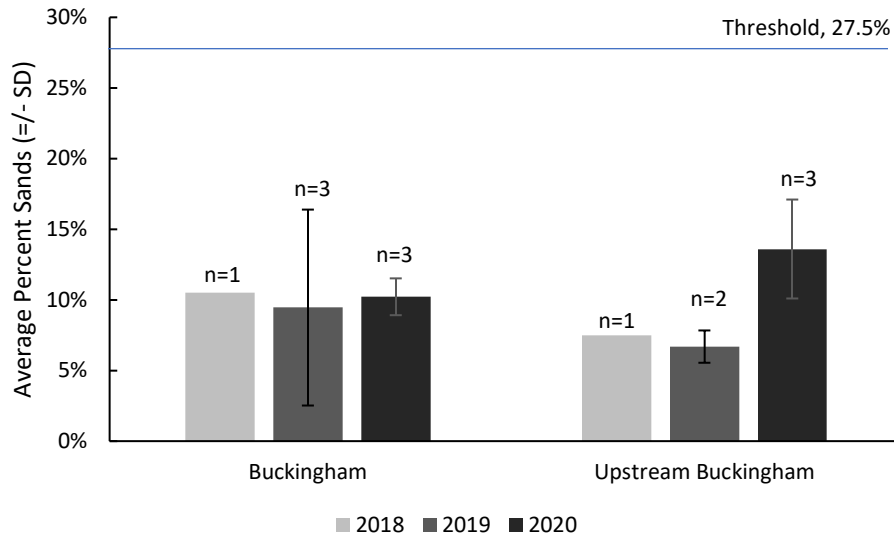
Pebble counts were collected from 2018 through 2020. We conducted pebble counts in one to three representative riffles at both Upstream Buckingham and Buckingham during low flow (August or September) and sample size increased from year to year. We found that during all sampling years, percent sands at both sites remained below the 27.5 % threshold (Figure 8). Notably, percent sands at upstream Buckingham increased to 13.6% fines in 2020 compared to 7% to 8% in previous years. This may be due to fine sediment mobilization during recent restoration work upstream of the site in 2019, or it could be due to sampling variability. Furthermore, we found no evidence of sedimentation issues based on the benthic macroinvertebrate (BMI) Tolerance Index Value (TIV) score (see Water Quality results; Table 3).

Figure 8. The 2018 through 2020 surveyed percent sands ( $\pm$  standard deviation) in riffles at Upstream Buckingham and Buckingham sites on Left Hand Creek. Sample size indicated by “n” above each average. Percent sands 27.5% threshold shown as a line and labeled.

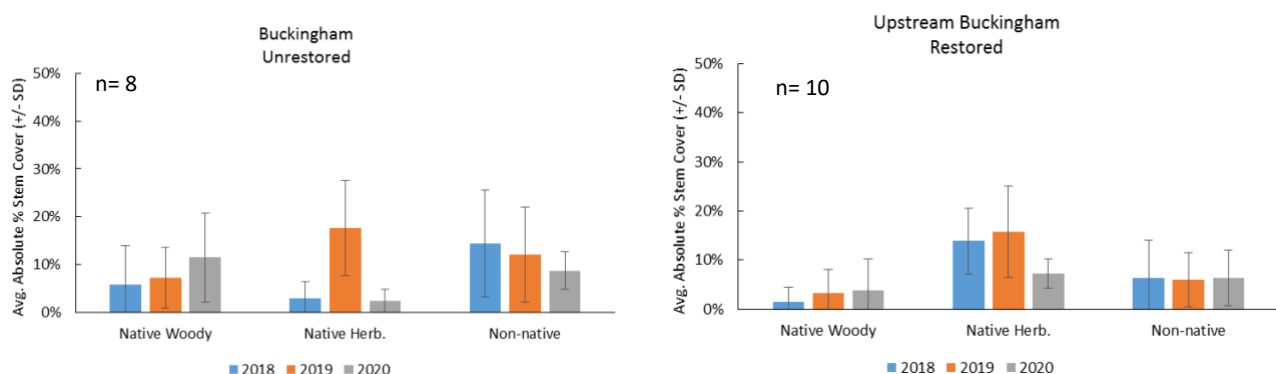
Notably, we found that Buckingham had greater percent herbaceous cover in 2019 compared to 2018 and 2020 (Figure 9). This intermediate increase in cover is likely due to annual variability in sampling timeframe and precipitation. In 2018, we sampled in the end of September, when we suspected some herbaceous species had already died and were therefore classified as bare ground (described as thatch). In 2020, the uncharacteristically low precipitation in July and August may have accelerated herbaceous die-off and resulted in classification of dead herbaceous species as bare ground (Figure 4). The 2019 growing season precipitation was more typical of climate records and likely resulted in greater herbaceous survivorship during sampling in August. These results highlight the variability in year to year sampling and the need for more long term monitoring to identify trends.

Figure 9. The 2018 through 2020 average absolute percent of cover types (+/- standard deviation) for all riparian plots at Buckingham and Upstream Buckingham on Left Hand Creek. Cover types are classified as Native Herbaceous, Native Woody, and Non-Native. Plot sample size for each site for all years is indicated by “n” value. See Attachment 2 for native and non-native species lists for each site.

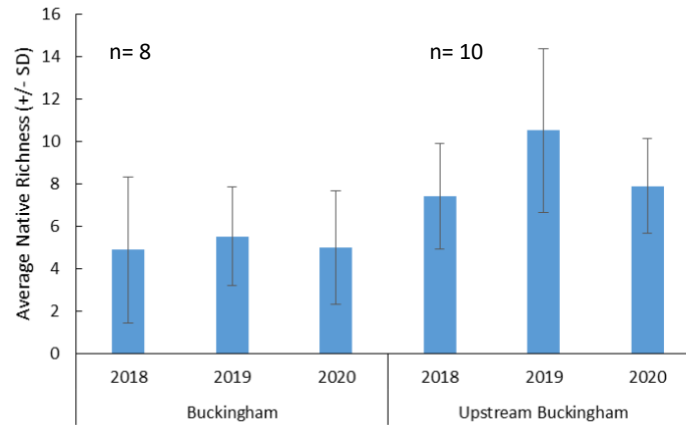
Figure 10. The 2018 through 2020 average native richness (+/- standard deviation) for all riparian plots at Buckingham and Upstream Buckingham on Left Hand Creek. Plot sample size for each site for all years is indicated by “n” value. See Attachment 2 for native species lists for each site.

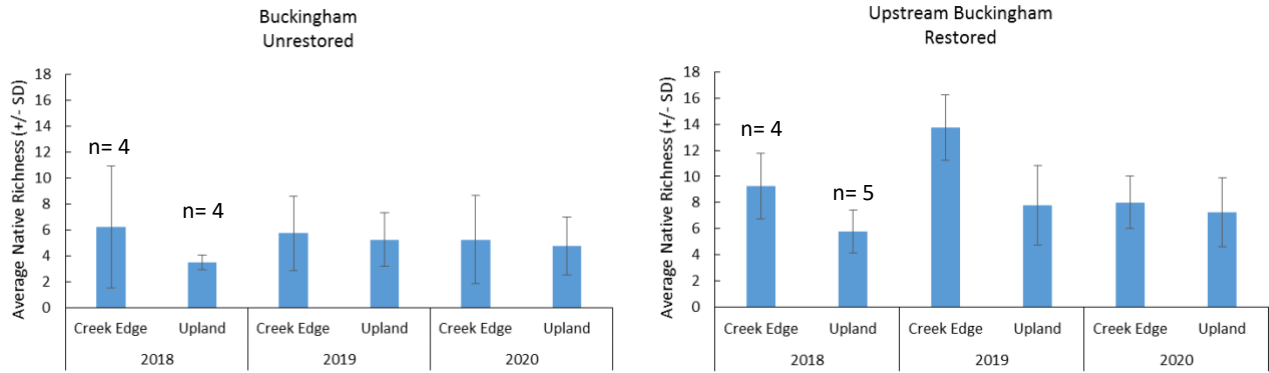
Figure 13. The 2018 through 2020 average native richness (+/- standard deviation) for Creek Edge versus Upland plots at Buckingham and Upstream Buckingham on Left Hand Creek. Sample size for each site and plot type for all years is indicated by “n”.

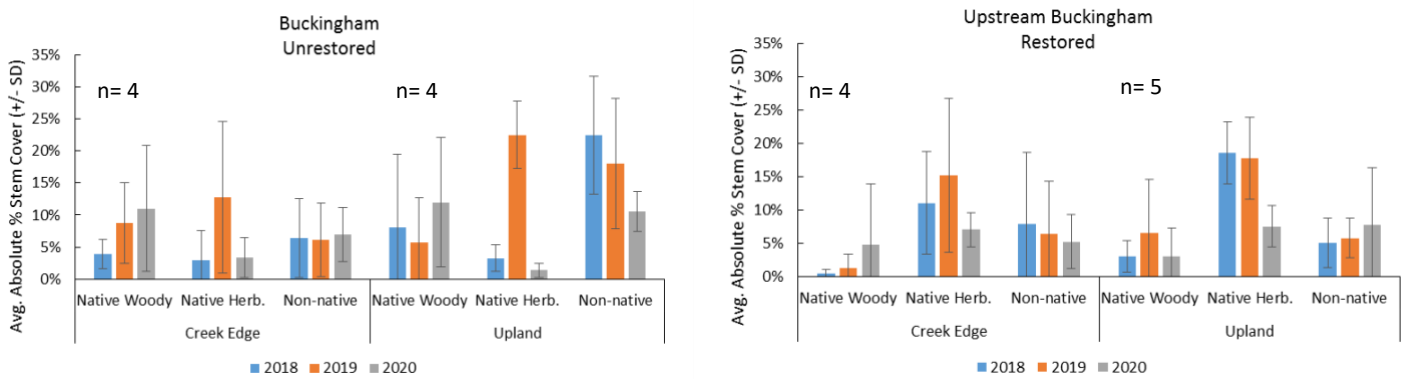
Figure 14. The 2018 through 2020 average absolute percent cover types (+/- standard deviation) for Creek Edge versus Upland plots at Buckingham and Upstream Buckingham on Left Hand Creek. Cover types are classified as Native Herbaceous, Native Woody, and Non-Native. Sample size for each site and plot type (upland or creek edge) for all years is indicated by “n”.

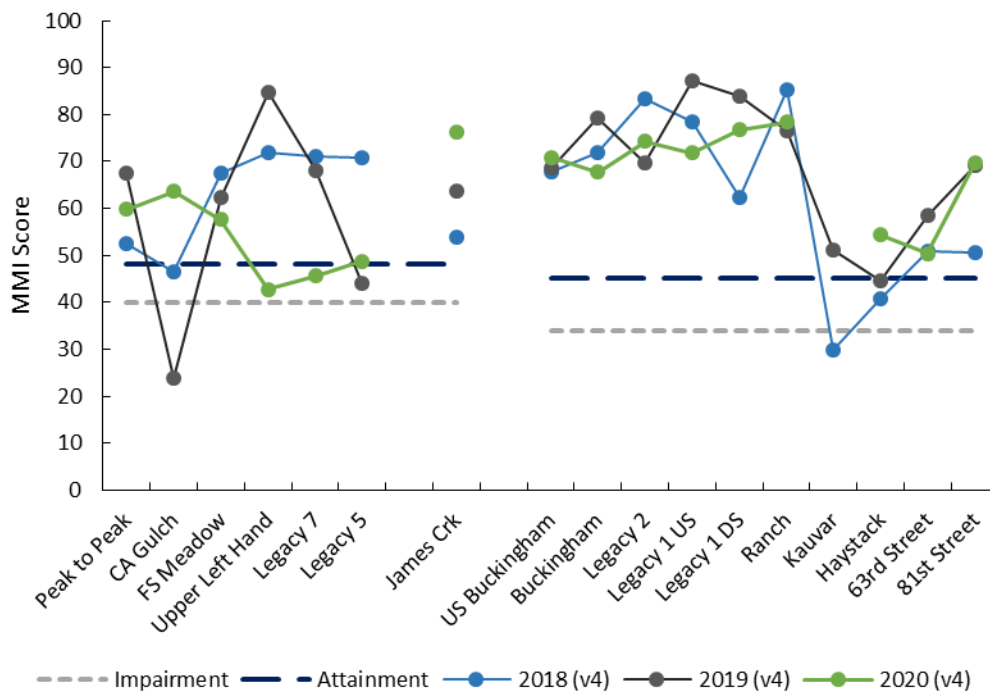
Figure 16. The 2018 through 2020 MMI Scores for Upstream Buckingham and Buckingham, as well as scores from 16 additional sites throughout Left Hand Watershed (16 on Left Hand Creek, 1 on James Creek). Attainment and Impairment thresholds, relative to watershed zone, indicated by dashed lines. MMI scoring version 4 was used for all sample analyses. Scores below the impairment threshold may indicate impaired water quality and scores between attainment and impairment need further assessment. Kauvar samples were not collected in 2020 due to dry conditions.

Notably, water quality remains good at the Buckingham sites and other foothills sites (Legacy 2, Legacy 1, Ranch), while upstream areas (Upper Left Hand and Legacy 7) show possible impairments and downstream site scores (Kauvar, Haystack, 63rd Street, 81st Street) have improved or maintain attainment (Figure 16). While upstream water quality issues in 2018 and 2019 were likely related to acid mine drainage from the Captain Jack Mine, possible impairment issues at Upper Left Hand and Legacy 7 are under investigation.

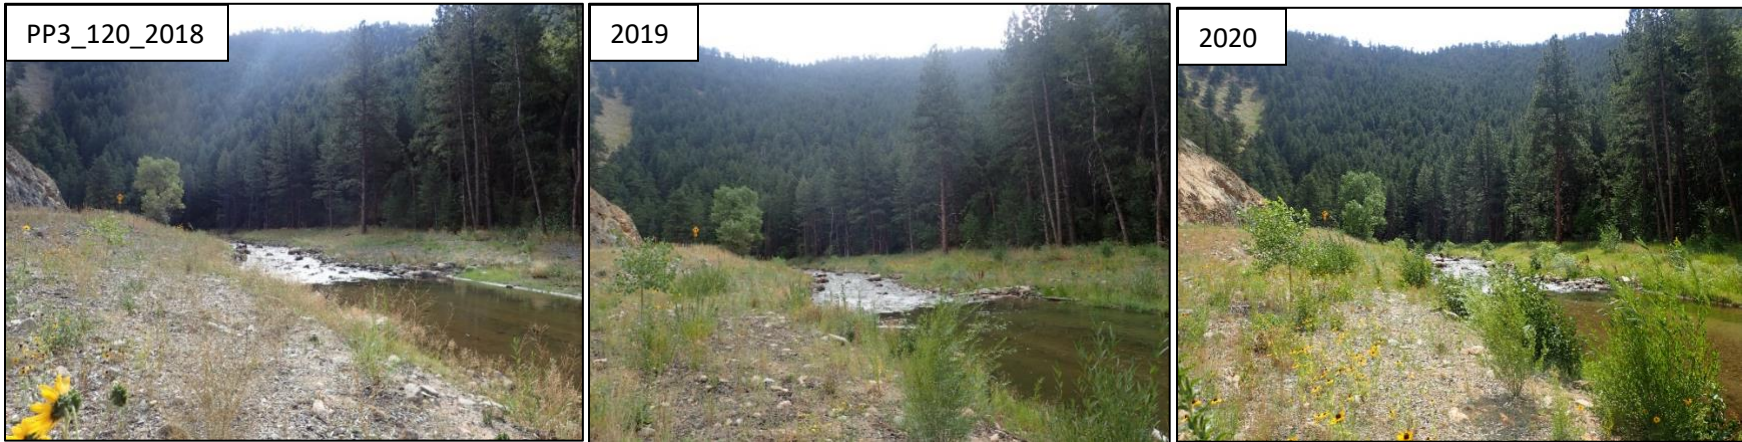
Figure 7. The 2018 through 2020 photos from photo point 3, azimuth 120 looking downstream from river left at Upstream Buckingham, Left Hand Creek.

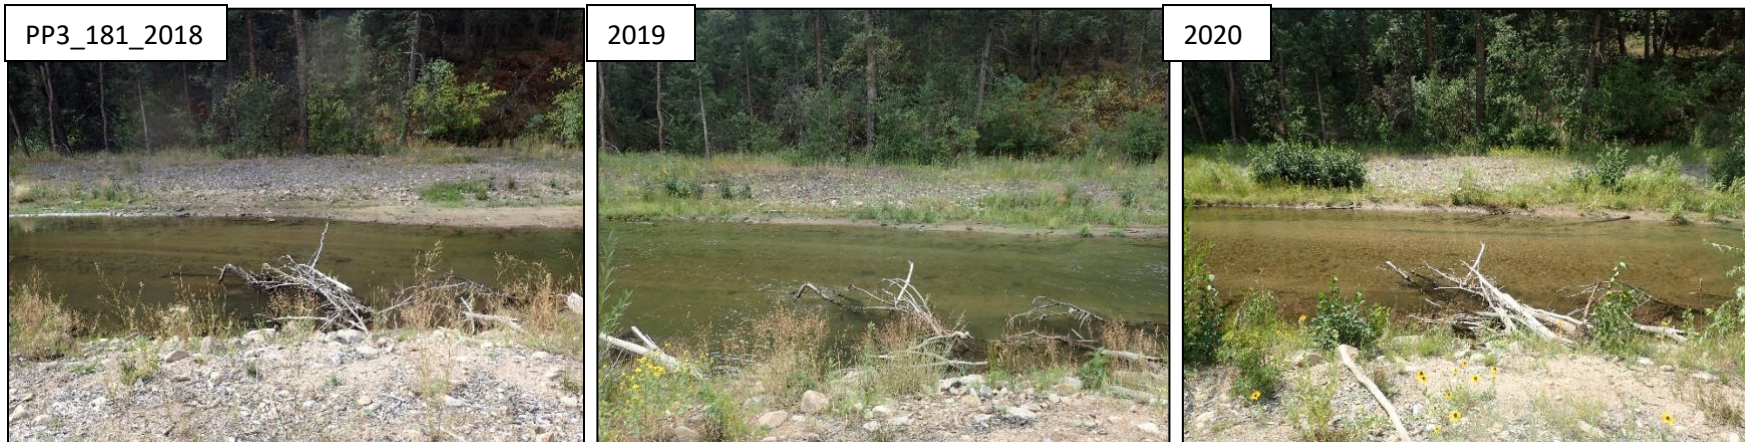
Figure 8. The 2018 through 2020 photos from photo point 3, azimuth 181 looking across from river left at Upstream Buckingham, Left Hand Creek.

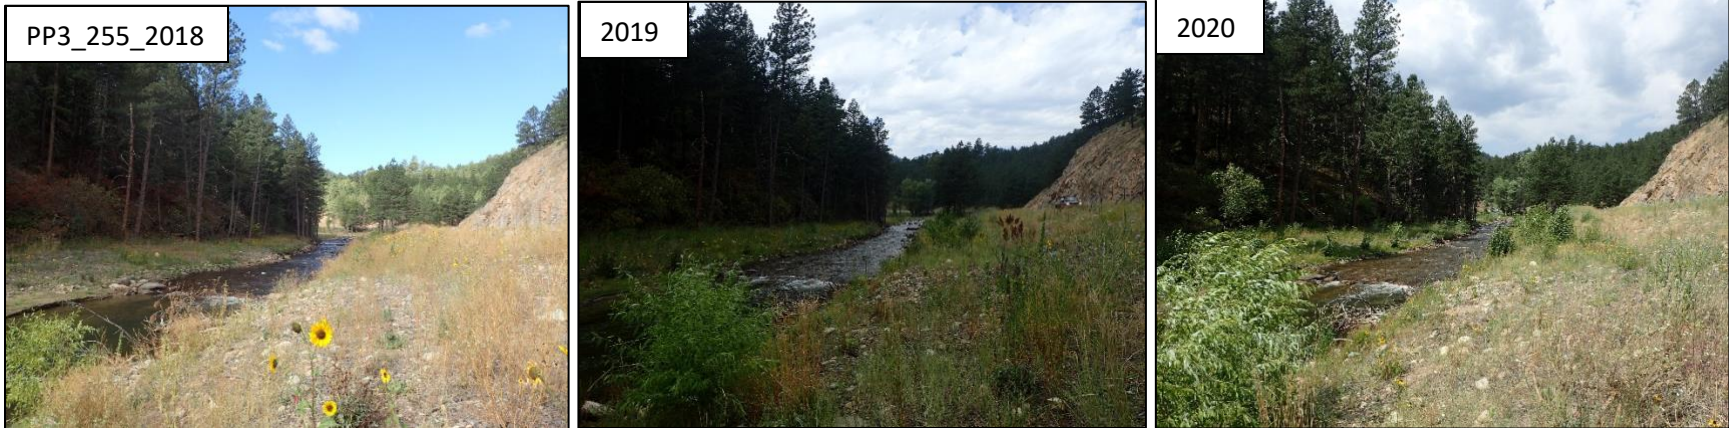
Figure 9. The 2018 through 2020 photos from photo point 3, azimuth 255 looking upstream from river left at Upstream Buckingham, Left Hand Creek.
