Assessing the Potential for Beaver Restoration and Likely Environmental Benefits

Final Report: July 2019

Julianne Scamardo and Ellen Wohl

Department of Geosciences, Colorado State University, Fort Collins, CO 80523-1482

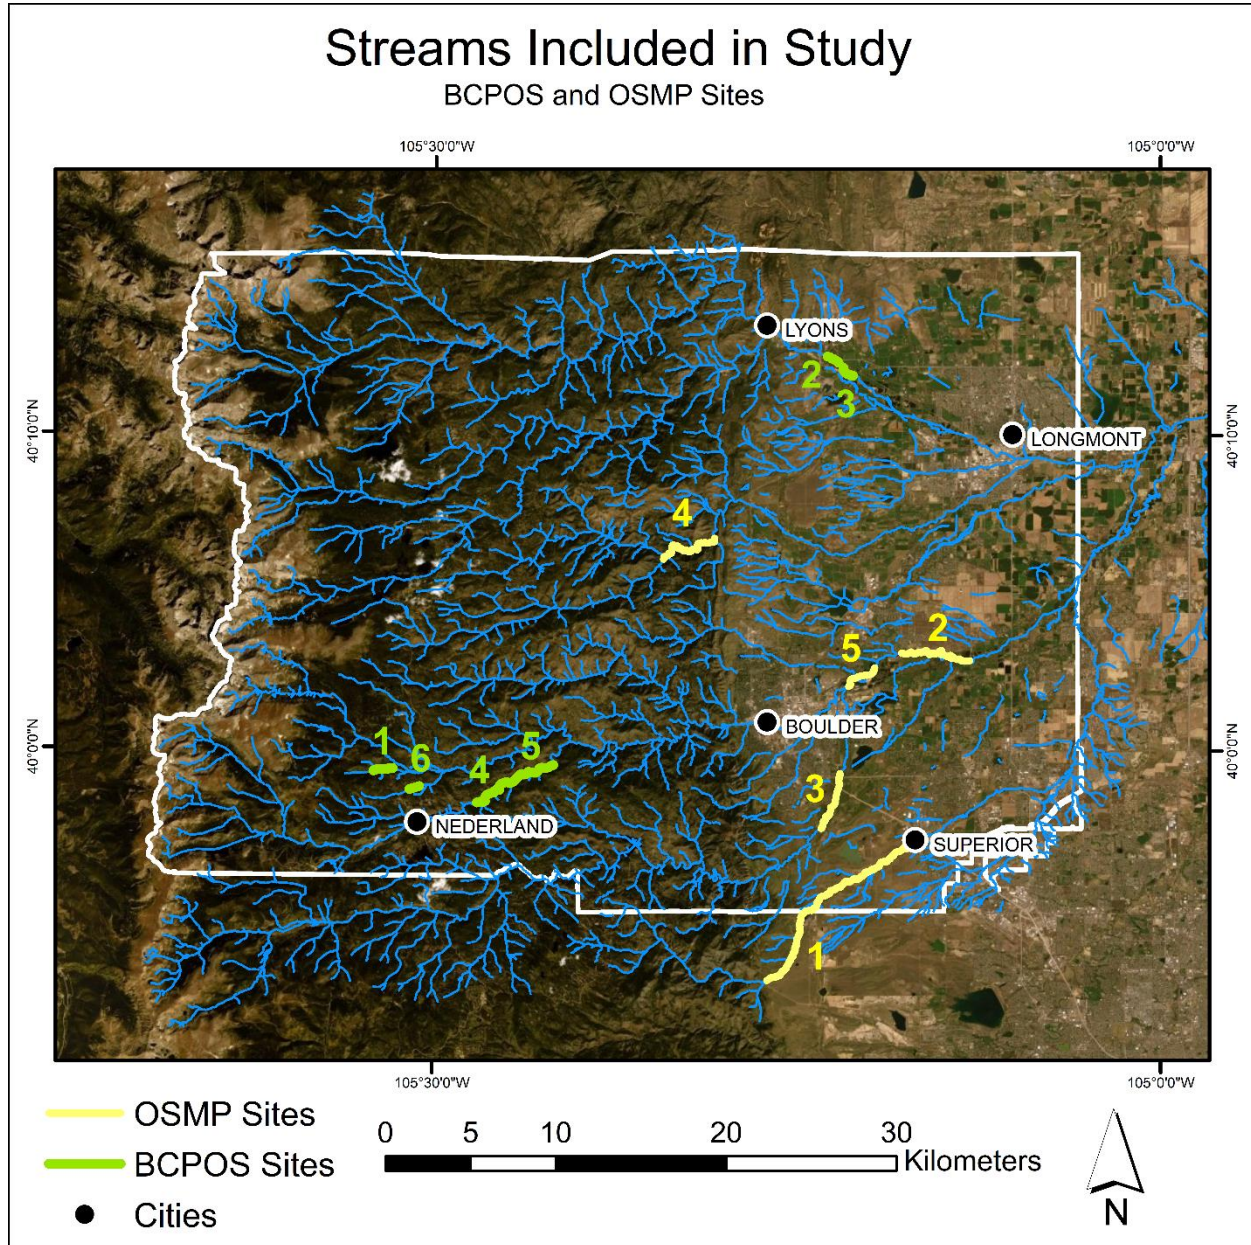
Figure 1. Map of City of Boulder OSMP and Boulder County POS study streams. Numbers indicate specific site name (see Section 3).

All sites within this study were located on public land. Stream reaches included in this study were chosen by Boulder County Parks and Open Spaces (BCPOS) and the City of Boulder Open Spaces and Mountain Parks (OSMP). The reaches investigated are listed below by managing agency and are shown on Figure 1.

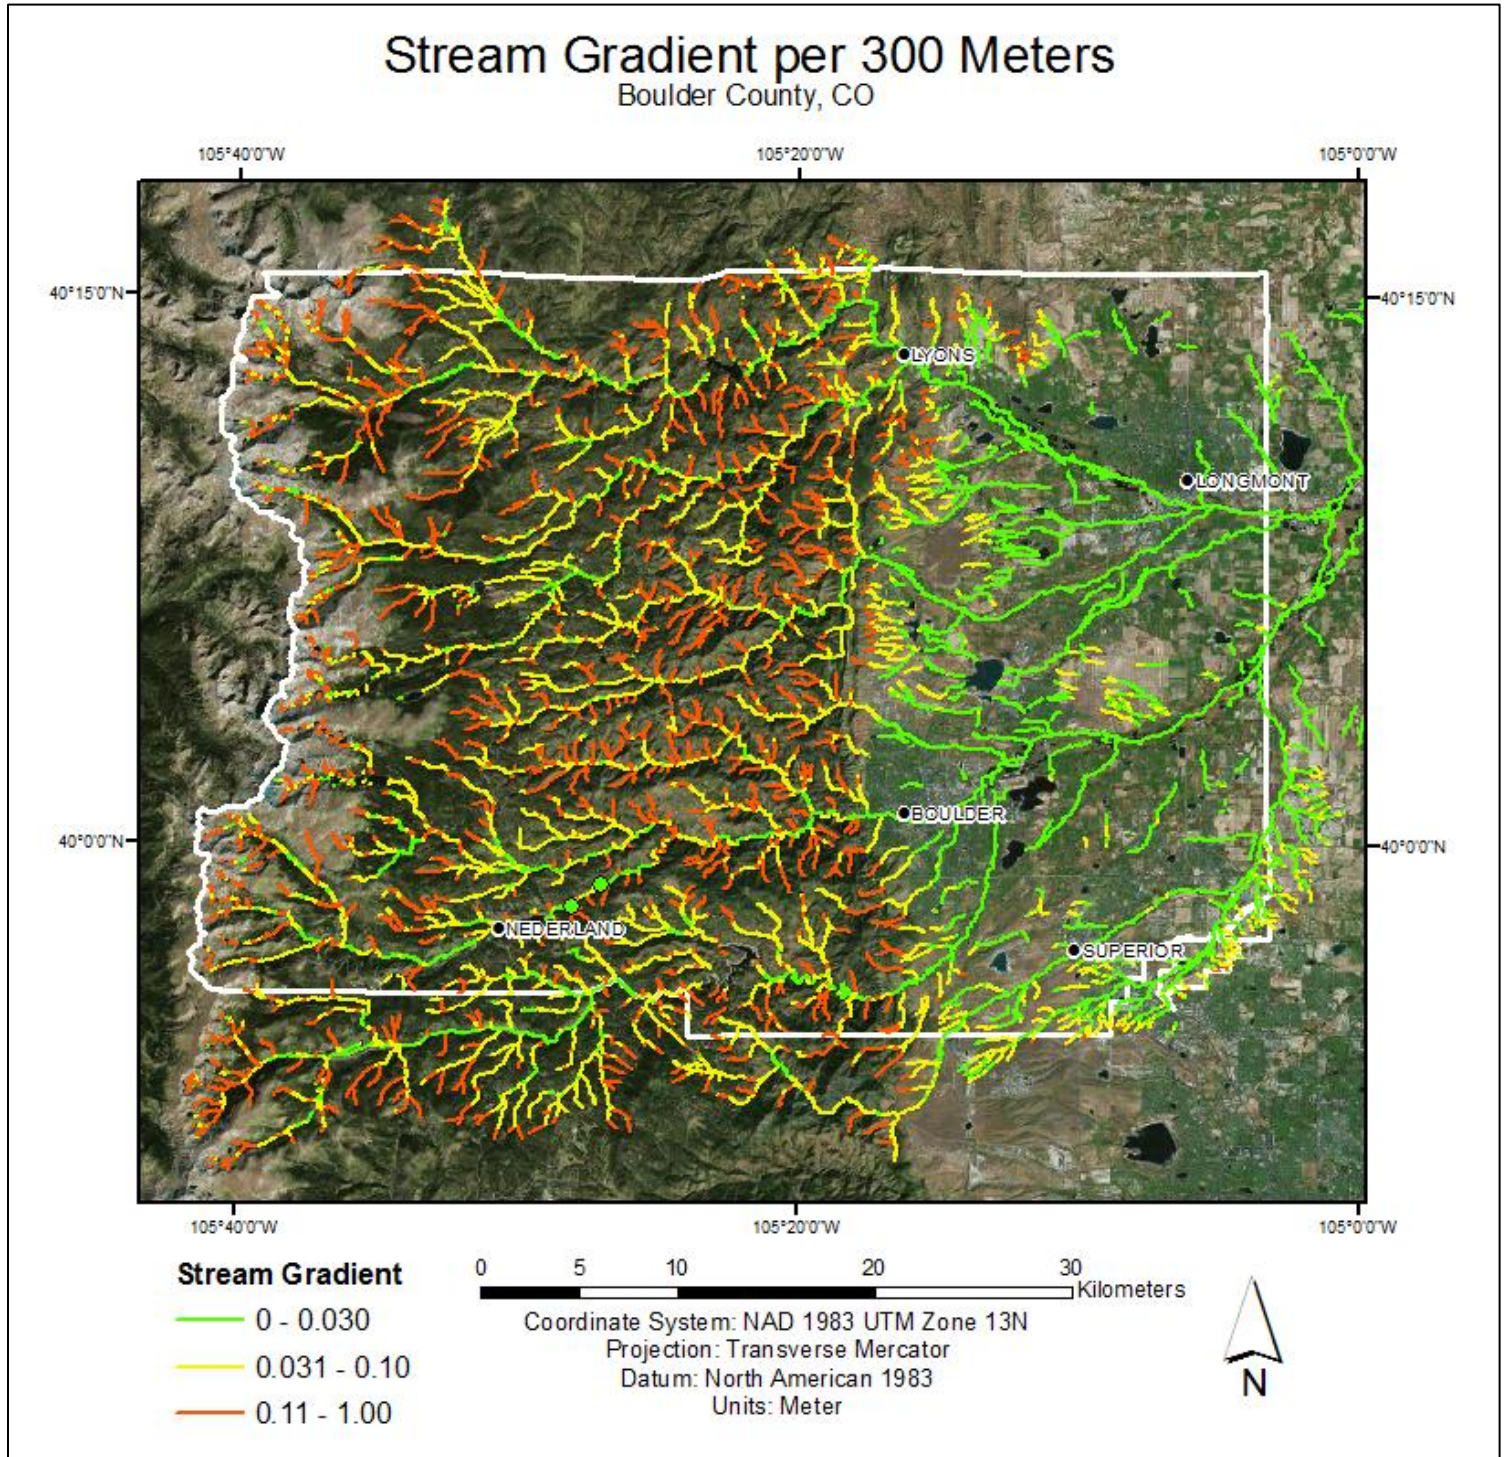
Figure 2. Stream Gradients of streams in Boulder County. Green stream segments are those with ideal gradients for beaver dams.

Continuous stream gradient was calculated for all stream segments using a digital elevation model (DEM) for Boulder County (Figure 2). Three different channel classifications were identified from the resulting dominant bedforms that would be present at each range of stream gradients: gradients of 0.00 – 0.03 m/m are pool-riffle reaches, gradients from 0.03 to 0.10 m/m are step-pool reaches, and gradients > 0.10 m/m are cascade reaches (Montgomery and Buffington, 1997; Wohl, 2014). Beaver are most likely to build dams in pool-riffle channel segments, although they are capable of building dams within the lower gradient range of step-pool channels. If the intent of reintroducing beaver is to maximize attenuation of downstream fluxes of water, sediment, and nutrients, however, beaver reintroduction should focus on stream segments with gradient less than approximately 0.05 m/m.

The valley bottom and floodplain along Middle Boulder Creek is confined by steep walls in Boulder Canyon. Valley bottom width in Roger Park varies from 50 to 70 m, which is narrower than typical beaver foraging distance. Un-wadeable flows in early August and large dominant substrate (cobbles/boulders) indicate that discharge may be too high for dam building. The proximity of Boulder Canyon Drive (Hwy 119) to Middle Boulder Creek further constricts the floodplain and limits habitat. Dam building material is moderately available along this stretch. Indicated by site 2 on Boulder Canyon map in Figure 2.

for dam building. However, the Platt-Rogers Park reach is isolated by less suitable vegetation and valley bottom widths directly up and downstream. Indicated by sites 1 and 3 on Middle Canyon map in Figure 2.

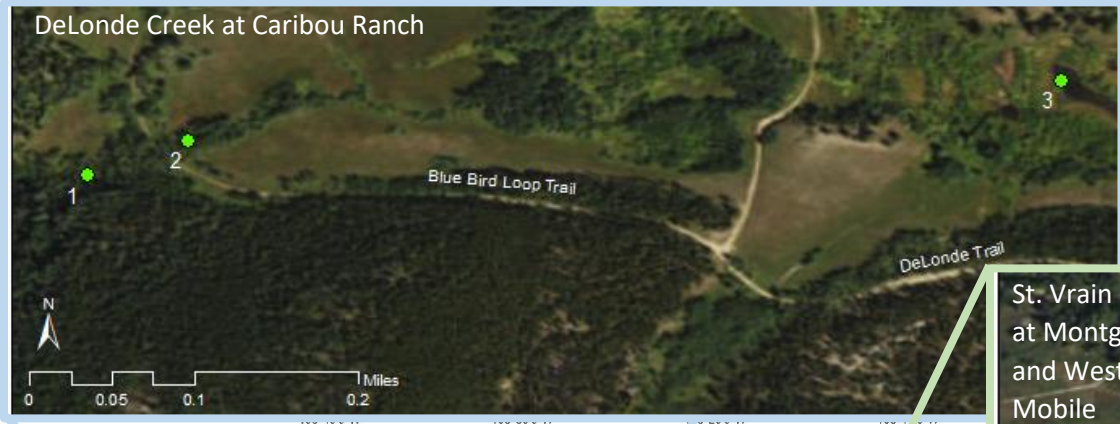
Figure 3. Map of Boulder County POS Sites including specific locations of geomorphic assessments

Eighteen geomorphic assessments across five sites were completed on POS property. The location of geomorphic assessments are labeled on Figure 3.

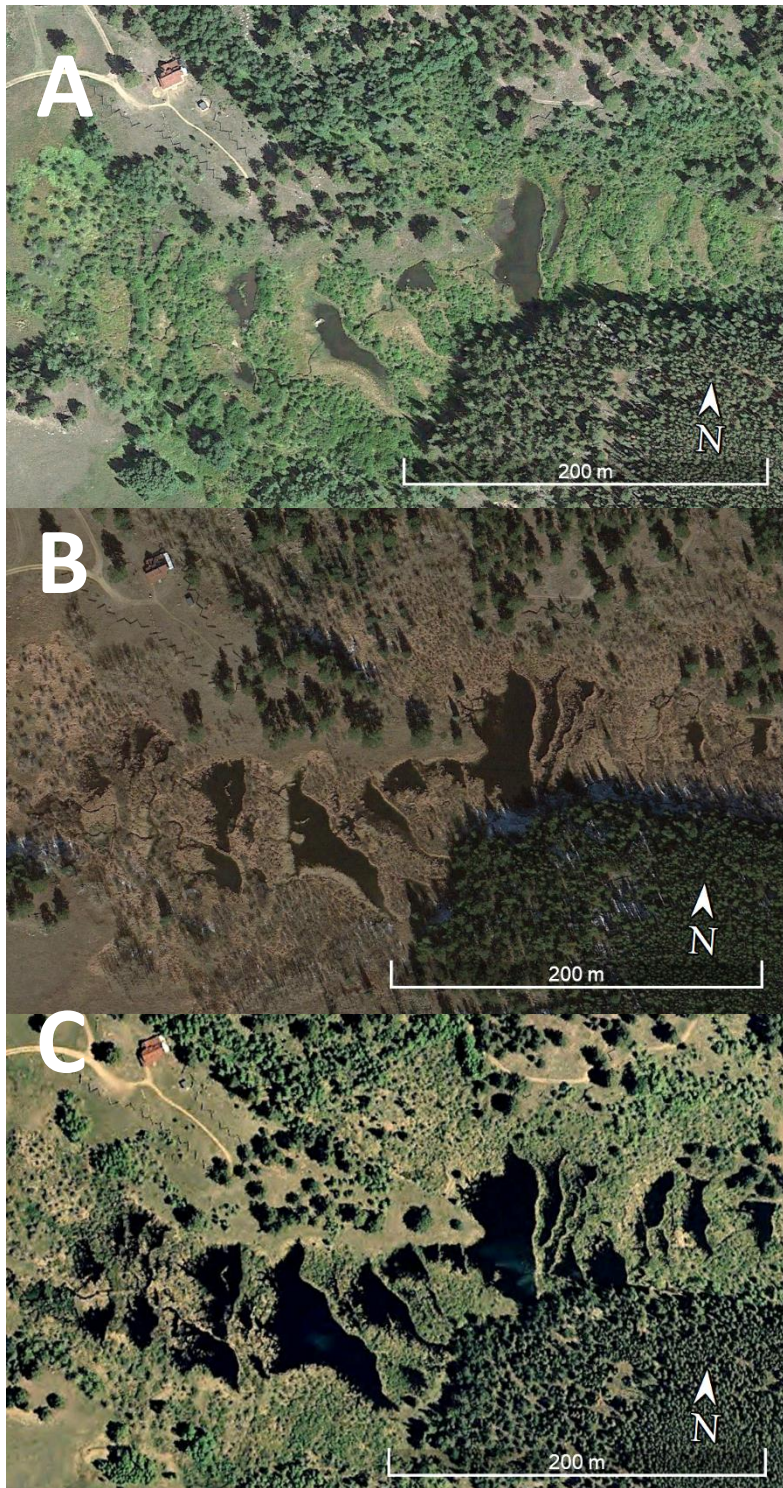
Figure 4. Google Earth imagery showing beaver pond surface area along Delonde Creek in Caribou Ranch Open Space over time. Imagery was taken on 9/7/2016 (A), 10/22/2013 (B), and 3/30/2008 (C). Beaver ponds have been shrinking in surface area due to beaver dam abandonment prior to 2008.

A series of 8 ponds directly south of the Delonde Homestead were identified as remnant beaver ponds. Remnant beaver dams are present at the downstream end of each pond as well as on the floodplain throughout the valley. Aerial imagery of Caribou Ranch dating back to 2008 shows a greater number of ponds that have since gone dry (Figure 4). Large stands of young willow and aspen are present within 30 m of Delonde Creek, and the valley bottom has abundant grasses. Heavy grazing of aspen and willow (the dominant dam building material at these sites) has occurred, likely by elk and moose (Figure 5). This suggests that beaver reintroduction might need to be accompanied by grazing exclosures.

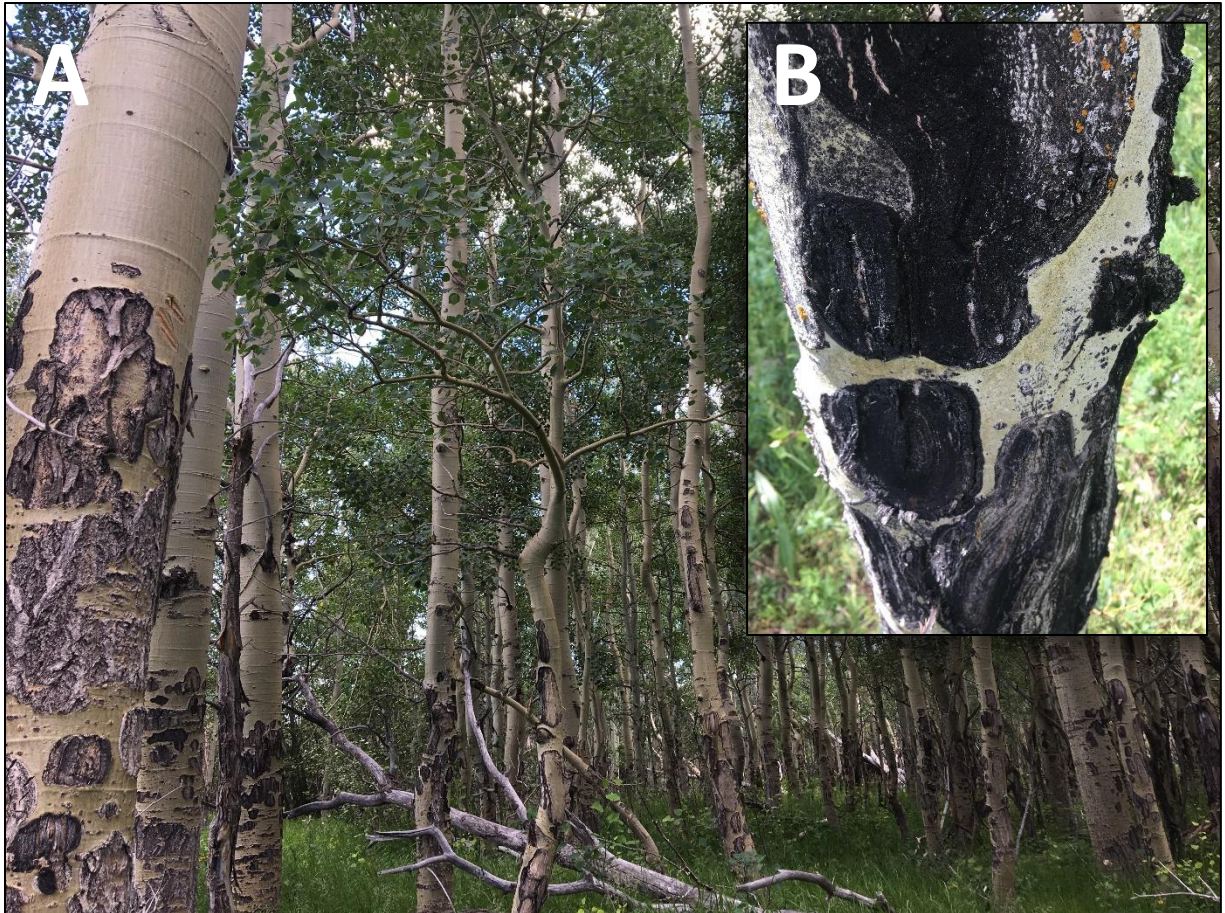
Figure 5. A stand of aspen grazed by moose and elk at Caribou Ranch Open Space near Nederland, Colorado. (A) While suitable vegetation is abundant, grazing is widespread and indicates a potential ecological conflict for beaver foraging. (B) Close-up of marks made by moose and elk. Similar evidence of grazing was made at multiple sites in the study.

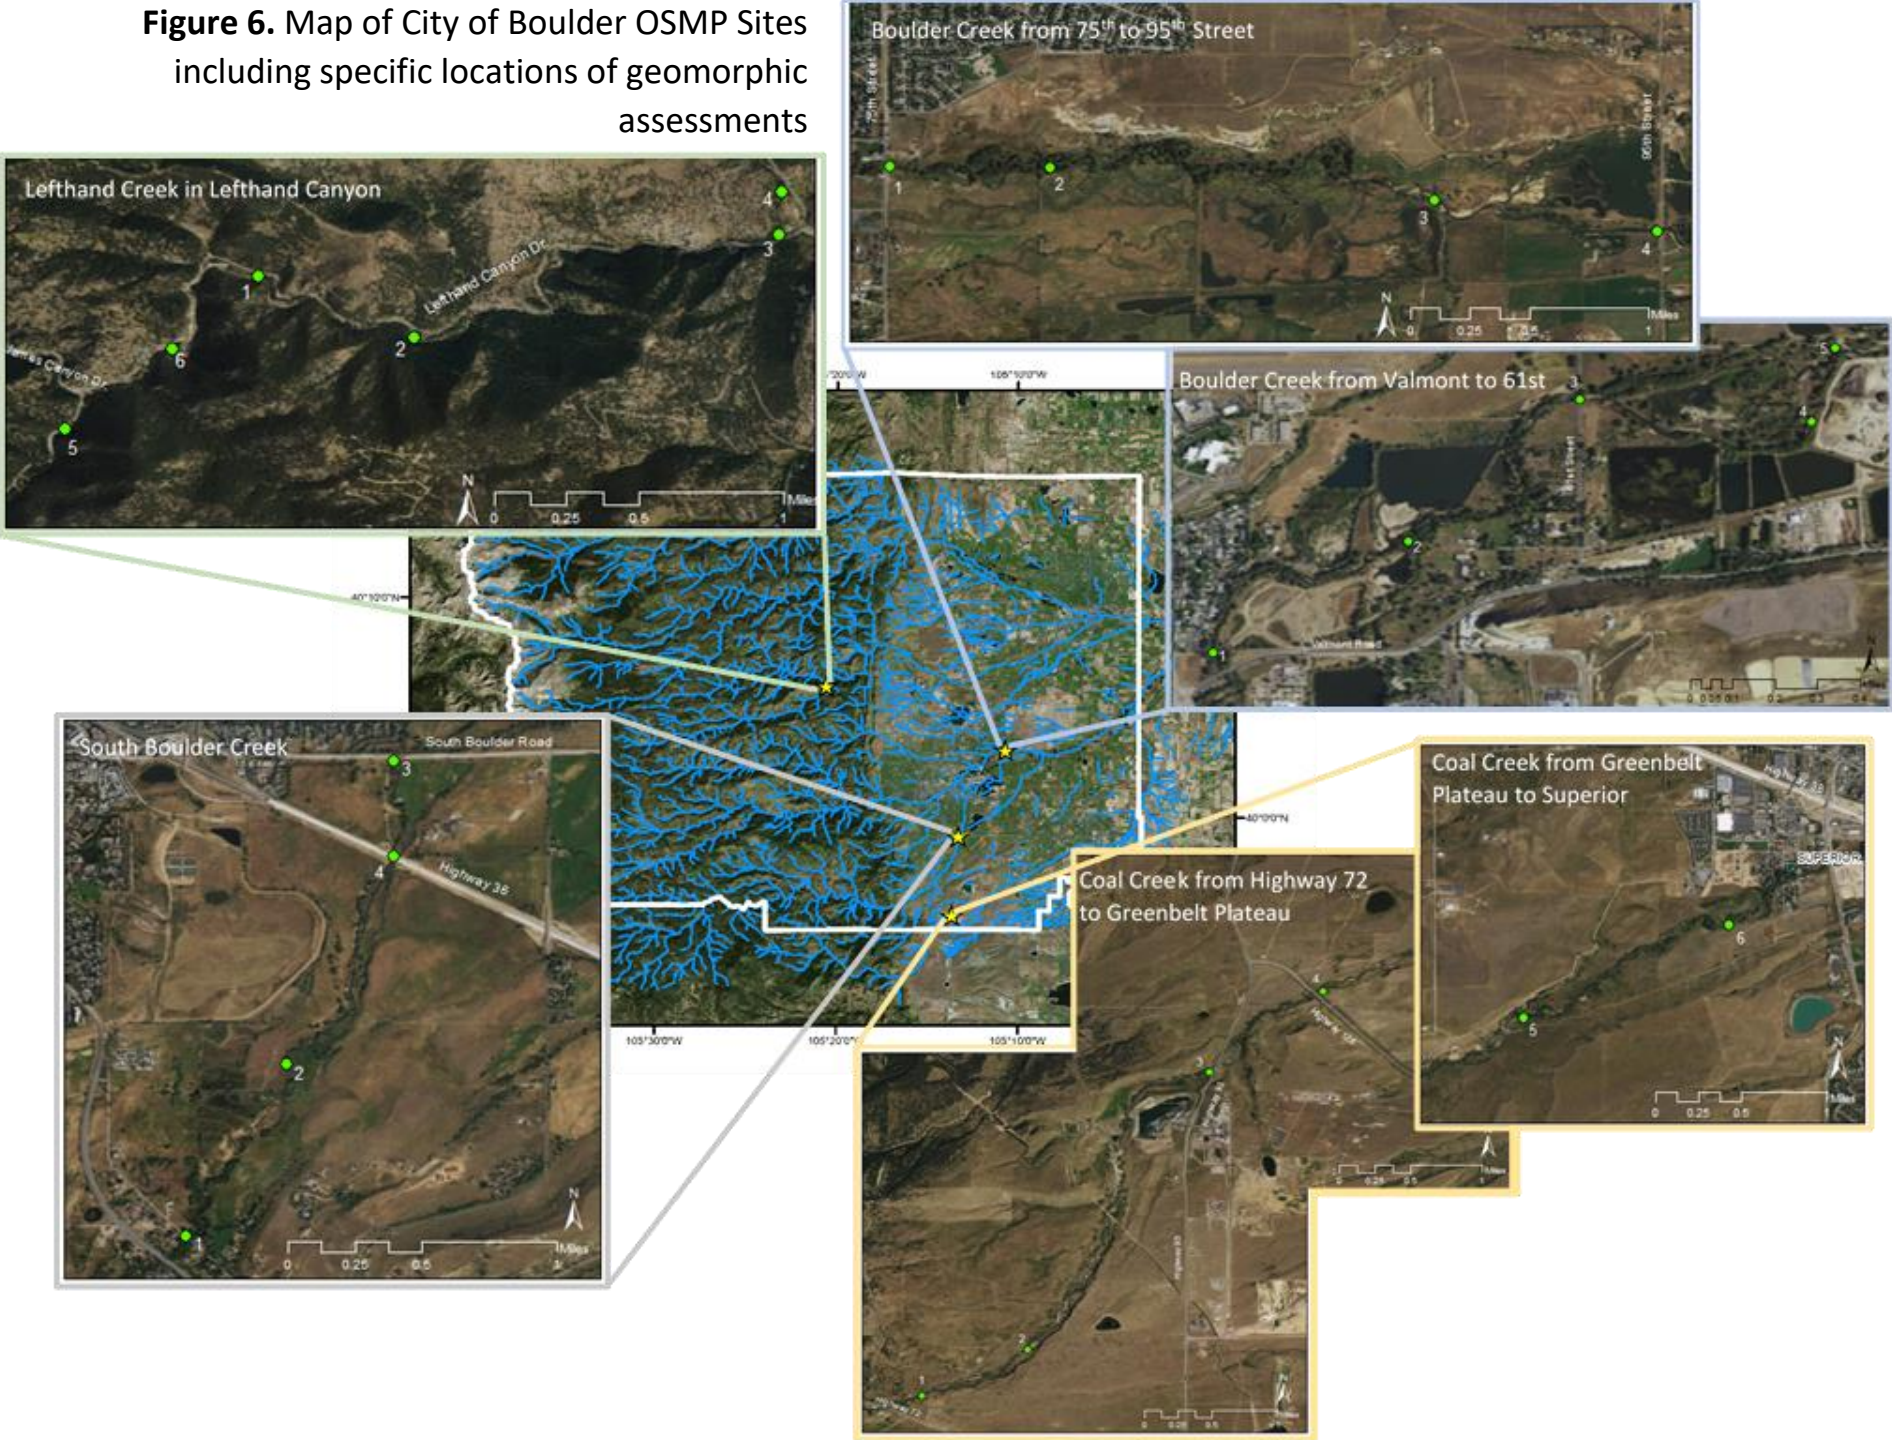
Figure 6. Map of City of Boulder OSMP Sites including specific locations of geomorphic assessments

Twenty-four geomorphic assessments across seven sites were completed on OSMP property. The location of geomorphic assessments are labeled on Figure 6.

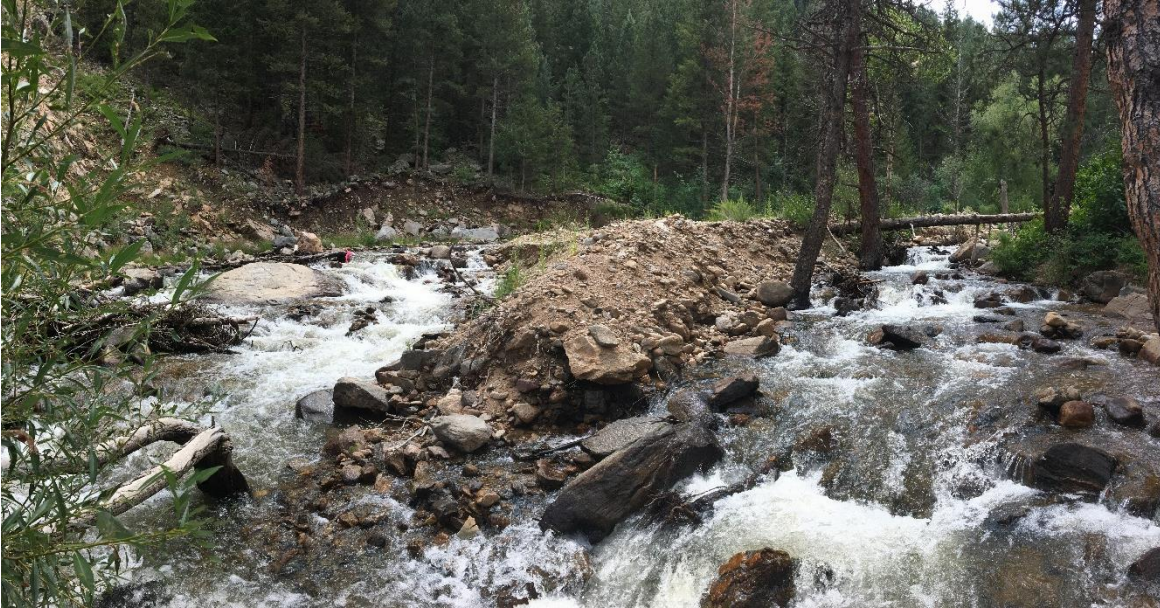
Figure 7. Left Hand Canyon near James Canyon Drive is steep in sections. Steep stream gradients are typically unsuitable for beaver establishment.

Left Hand Creek near James Canyon Drive was un-wadeable in early August, suggesting discharge and channel gradient are too high for dam establishment (Figure 7). Cobbles and boulders are the dominant grain size in this stretch, which is further evidence that high flows could hinder dam building. Valley bottom width is narrow in Left Hand Canyon, but widens at Buckingham Park. Throughout the canyon, Left Hand Drive further restricts the valley bottom width (Figure 8). Viable vegetation for dam building is moderately abundant in Buckingham Park compared to sites upstream (Figure 8).

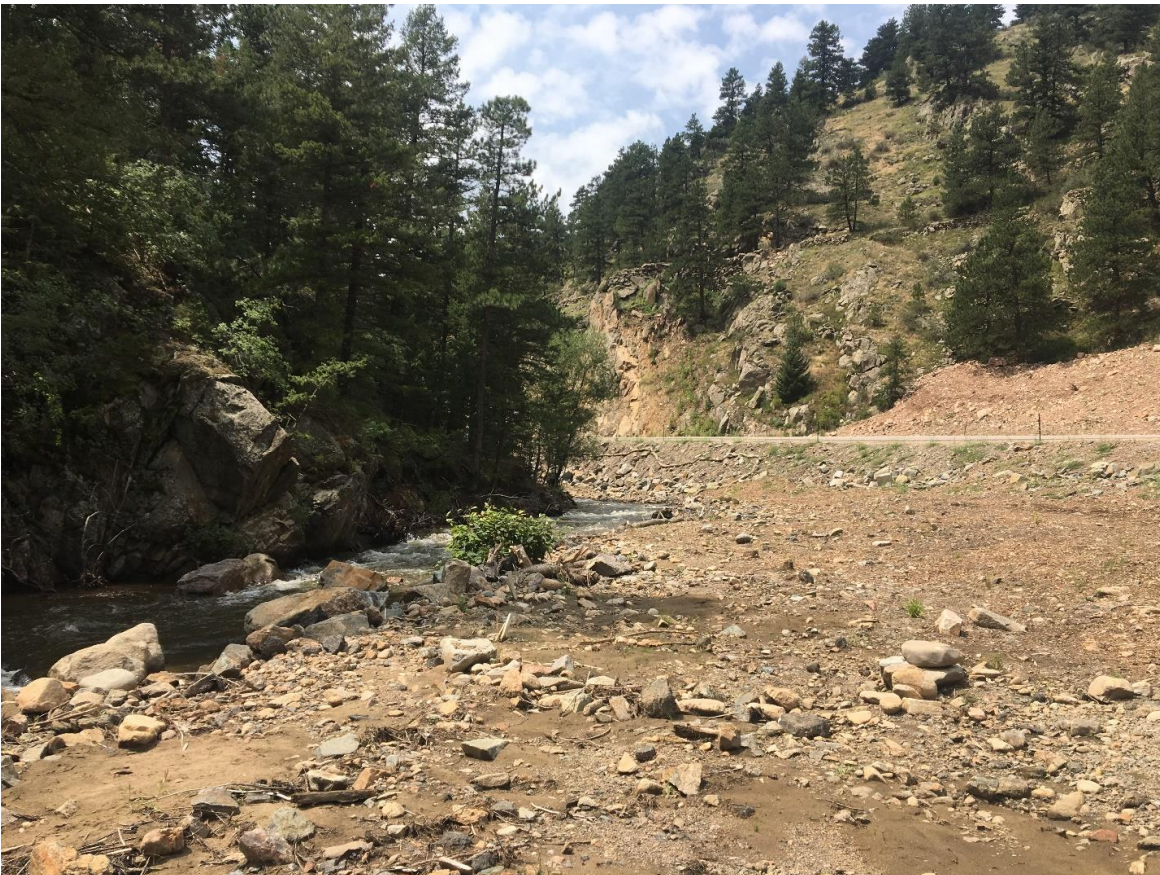
Figure 8. Lack of vegetation upstream of Buckingham Park could also limit beaver reintroduction along Left Hand Creek in Left Hand Canyon. Left Hand Canyon Drive further restricts the limited floodplain.

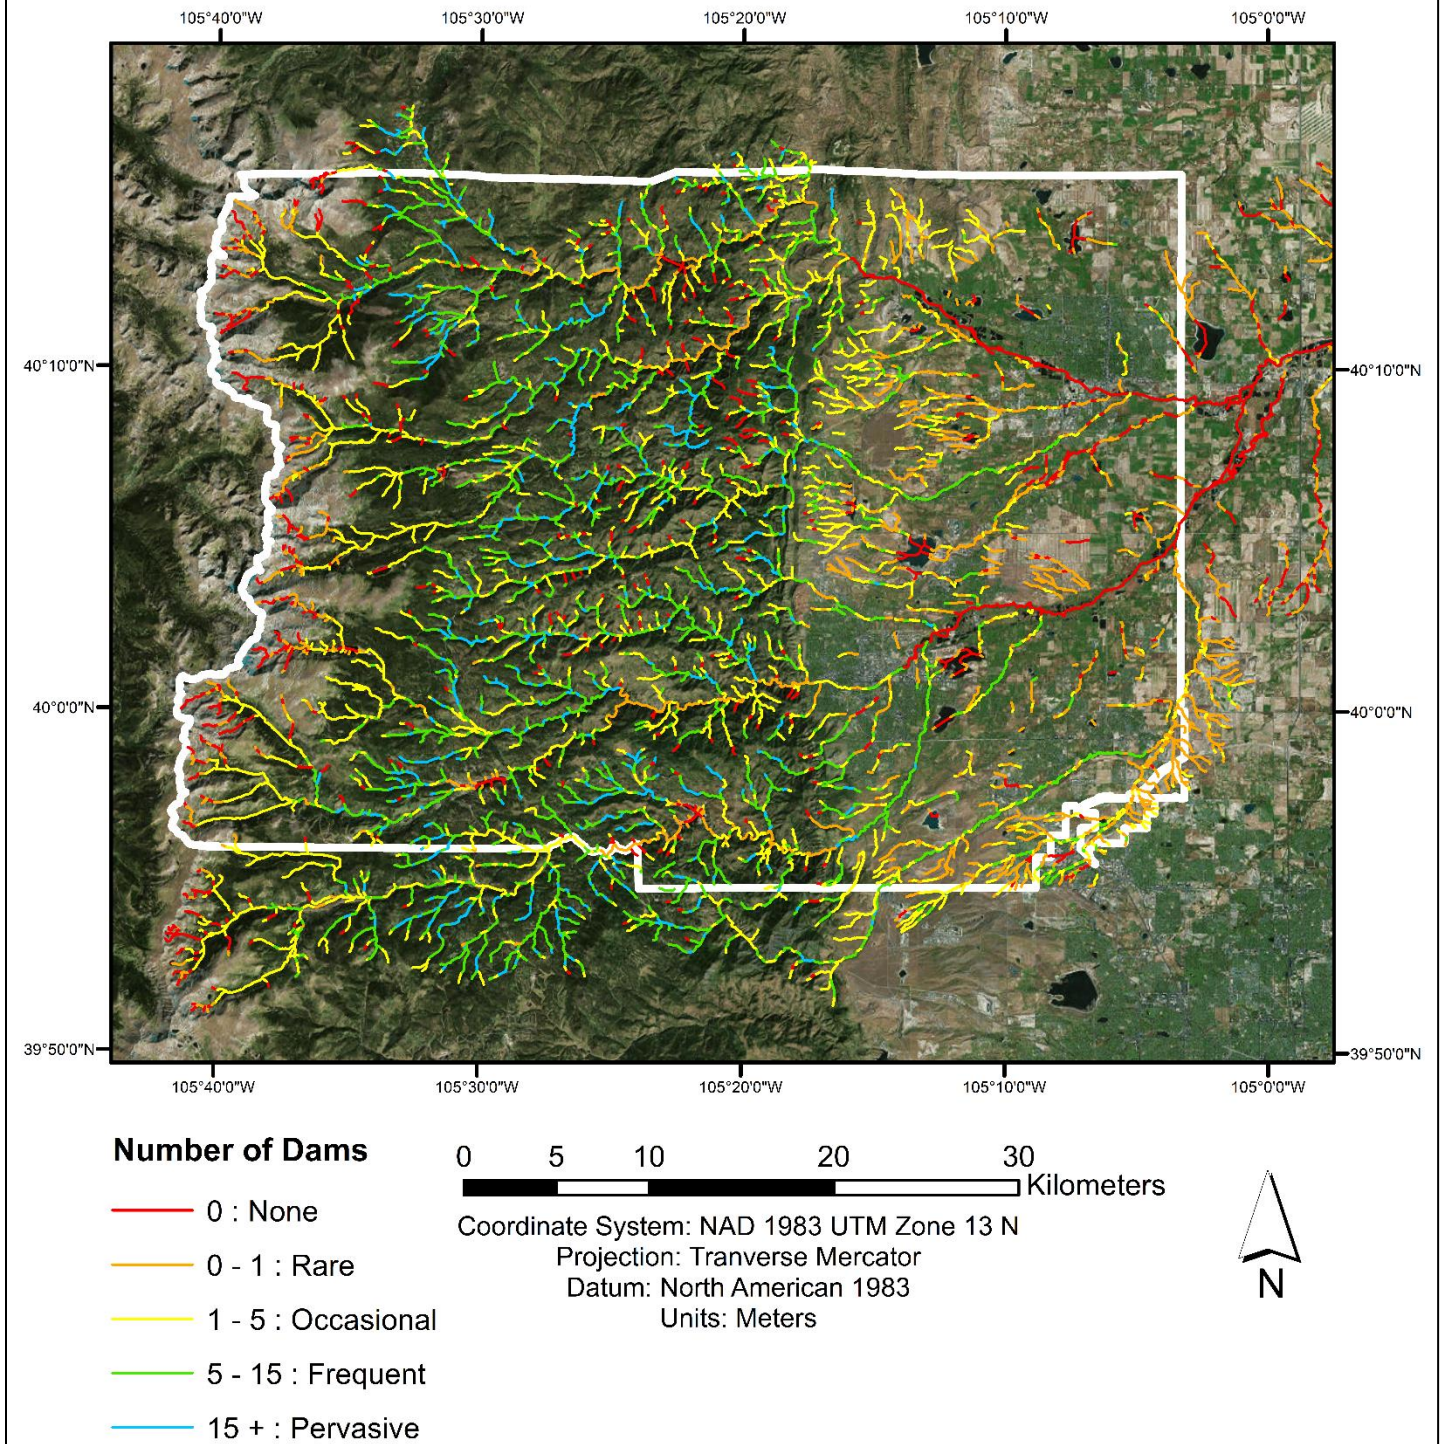
Modeled Beaver Dam Density

Boulder County, Co

Figure 9. BRAT output for all streams in Boulder County. Blue lines indicate 300 meter segments where North American beaver are or would be pervasive.

BRAT was modeled for the entire St. Vrain watershed in order to capture all the studied streams on OSMP and POS property (Figure 9). The BRAT output highlights areas of the watershed where beaver dams would not be viable such as steep, headwater streams in the mountains as well as deep, main-stem channels discharging onto the plains. High abundance of beaver dams are predicted in low-order, mid-elevation streams that typically alternate between confined and unconfined valleys and are flanked by suitable riparian vegetation.

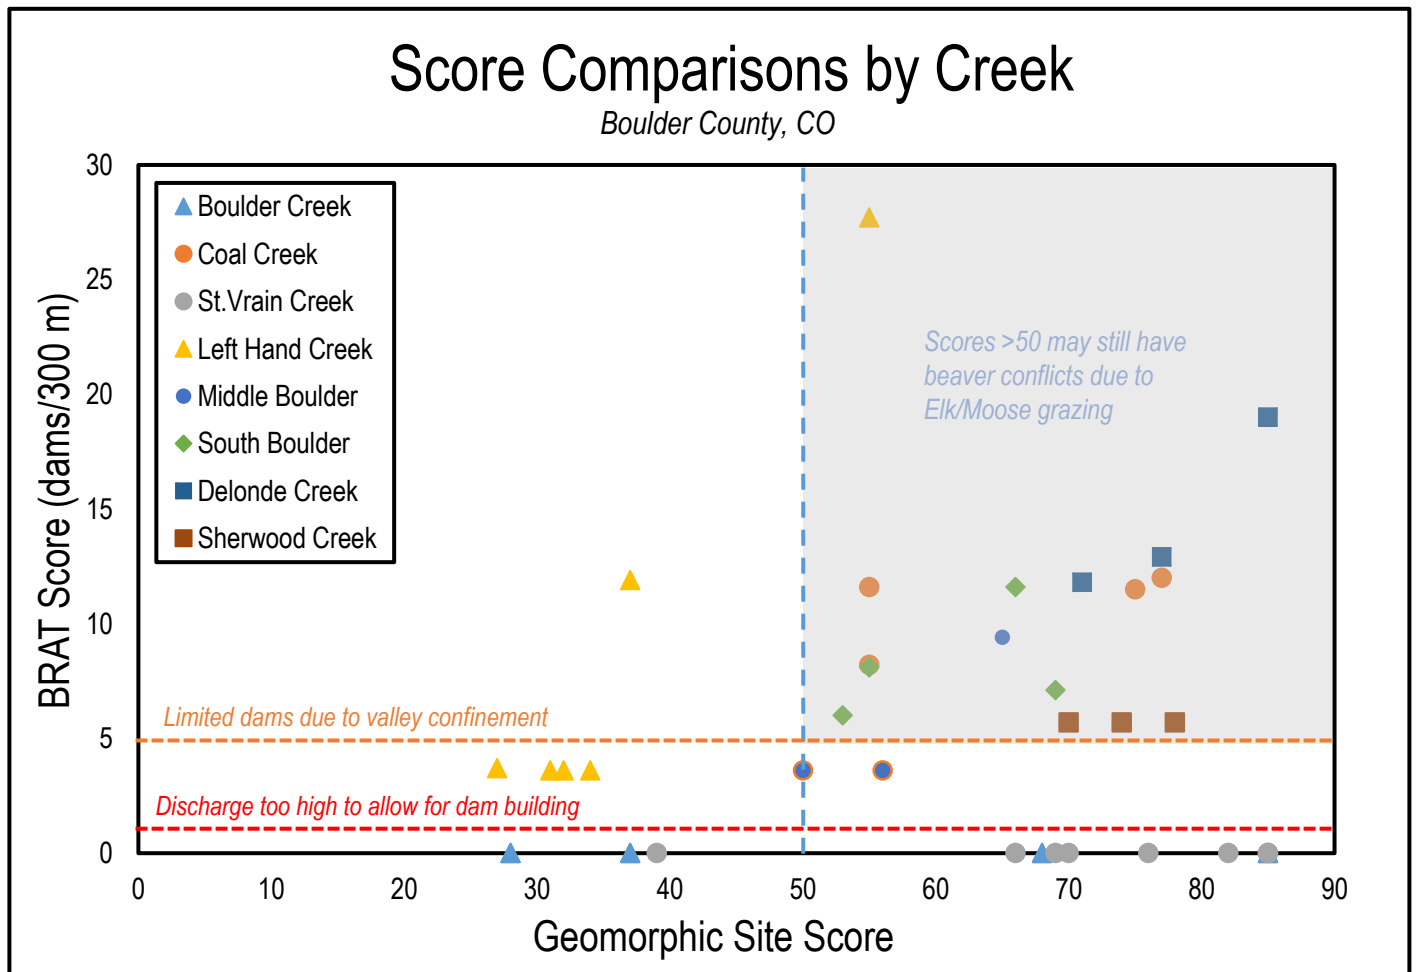
Figure 10. BRAT comparison by field site. Dashed lines represent a gradient between site suitability alternatives. Reasons for the dashed lines are given in text. Specific sites at each creek can be found in the supplemental Excel file.

The modeled density of beaver dams as determined by BRAT was identified for each location that a geomorphic assessment was completed in Boulder County. While these numbers are useful in tandem, there should not be a direct 1:1 correlation. Geomorphic assessments assign a score from 0 to 100 of site suitability based on vegetation abundance and size, human hazards, and grain size. BRAT assigns the capacity of dams per 300 meter reach of stream (usually less than 30). Additionally, BRAT does not consider human hazards, elk grazing, or the size of vegetation, which can affect the dam building capacity of beavers. BRAT does consider a range of hydrologic conditions that are difficult to assess in the field, such as the discharge at baseflow and during a typical 2-year flood. Site-by-site comparisons of the geomorphic assessments and BRAT are given by stream in Figure 10, below.

We recommend that the City of Boulder OSPM and Boulder County POS focus potential beaver restoration efforts on streams located within the shaded rectangle of Figure 10.

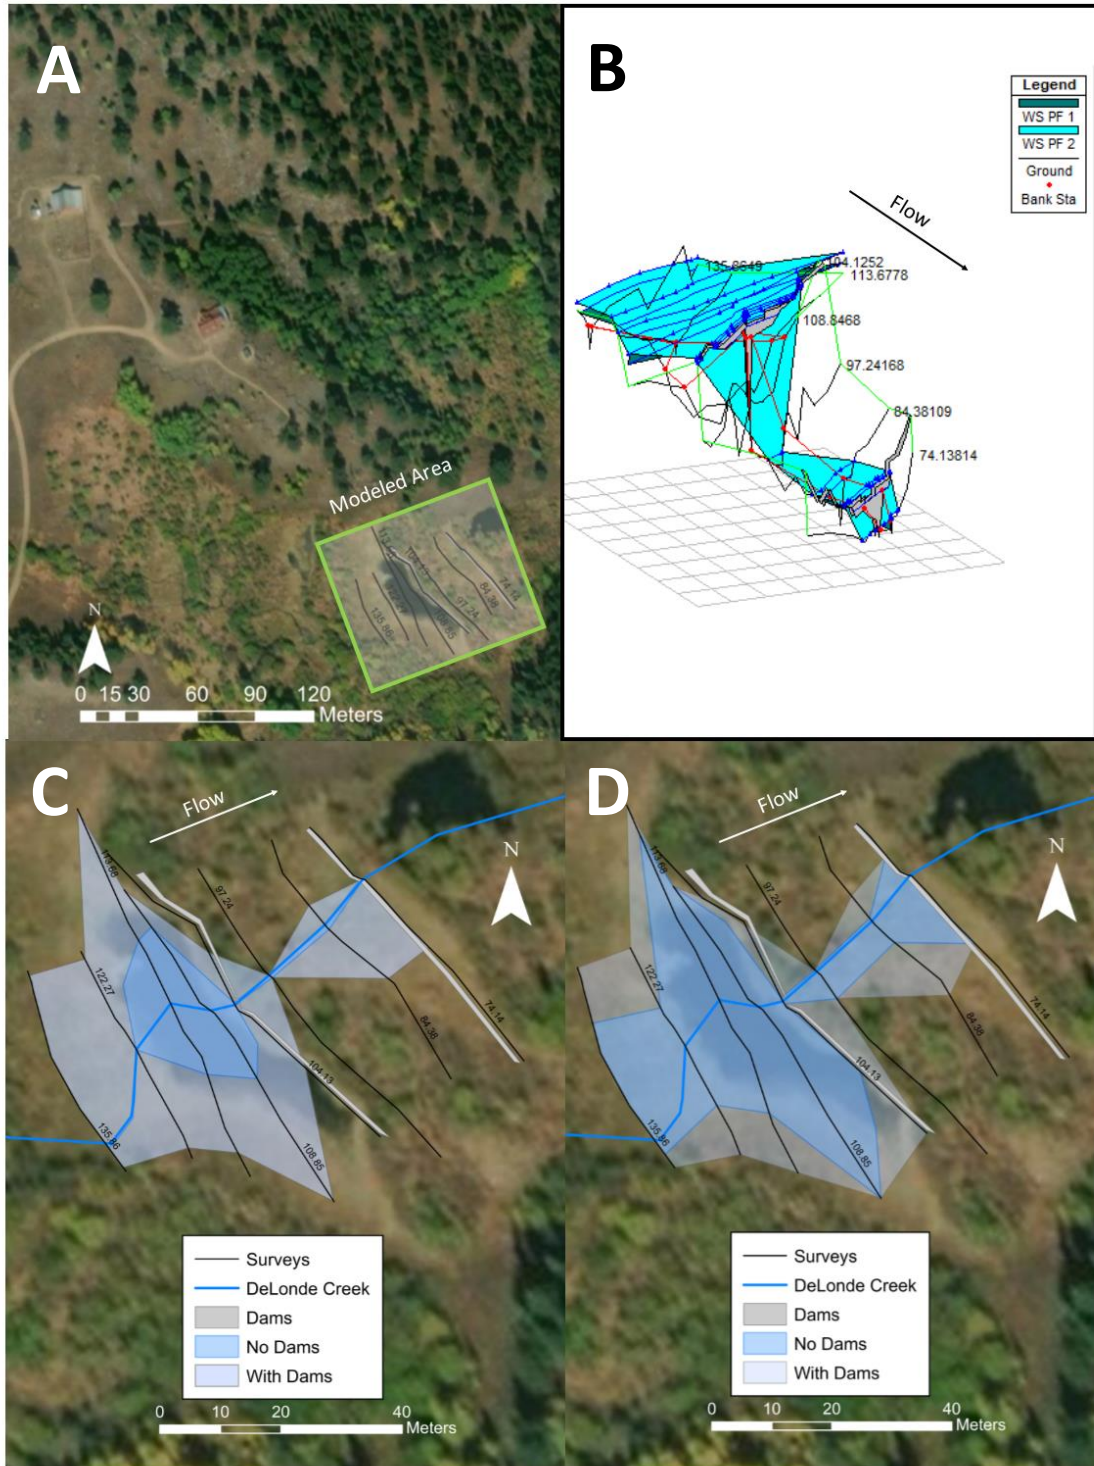
Figure 11. Model results from Delonde Creek. (A) Modeled area in context with surrounding infrastructure at Caribou Ranch Open Space. (B) Model setup and output in HEC-RAS. (C) Water extent at low flow with and without dams. (D) Water extent at high flow with and without dams.

Dams were modeled at reasonable places at each site. The two dams on Delonde Creek were modeled on top of old abandoned beaver dam berms, which would be the simplest place for a beaver to rebuild a dam (Figure 11). At Sherwood Creek where berms are less obvious on the landscape, the beaver dam was modeled where the stream was less incised and a stand of aspen is within foraging distance (Figure 12). Beaver are more likely to build a dam where the stream and dam building material are easily accessed. The dams were modeled to be 0.5 to 0.7 m high depending on channel dimensions. A 5.0 x 0.1 m notch was included at the top of each weir to account for some of the permeability of a beaver dam.

At both sites, dam building will increase inundated area (Table 2, Figures 11 and 12). The increase in inundated area will be more pronounced at baseflow than at high flow. For example, if one beaver dam was built at Sherwood Creek, it could increase wetted area during baseflow by over 500%. At high flows, the same dam would increase wetted area by 48%. Therefore, beaver dams could increase wetland area during typical low flows without causing devastating flooding during typical high flows.
